St Mary's Congerstone  
Main street  
Nuneaton

Drawing Status	Drawn by	Date
Stonework Details	SRE	26/01/18

Drawing Number	Revision
0045 -	A.04.4

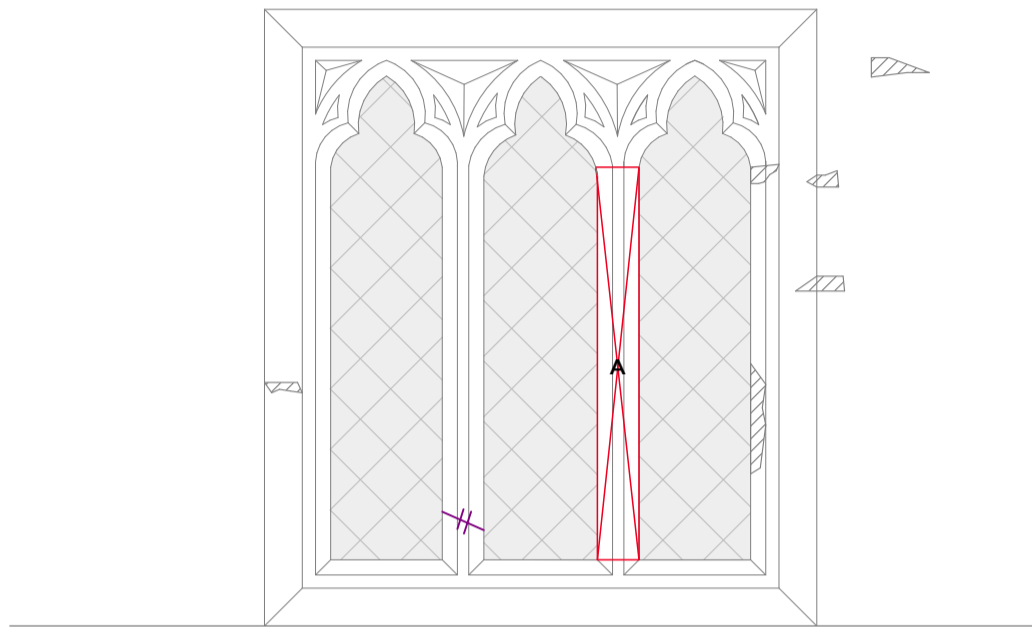
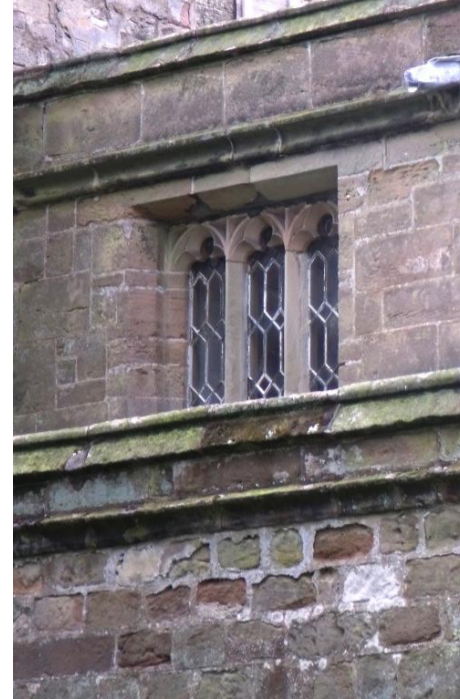
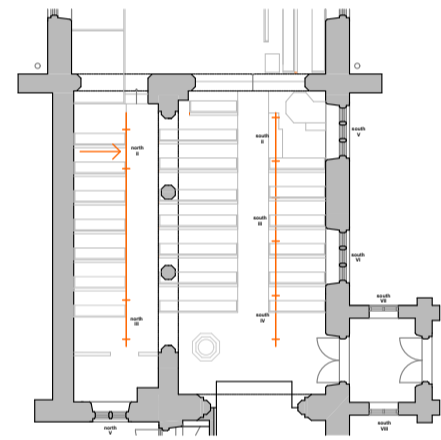
## window clerestory north II

Cast iron glazing bars to be carefully removed and repaired.

1. Replace right mullion to glass line.
2. Note that the stone is quite weathered at low level internally to this mullion, but is thought to be structurally sound and stable. However, PROVISIONALLY allow for the extra-over cost of replacing this mullion to full depth.
3. Remove old repairs including hard grey cement and re-do in lime mortars, to jambs and head as indicated.
4. Fill aveolar weathering holes on right-hand side where shown.
5. Insert two small pins across spall to left-hand mullion at low level, where shown, and grout and fill crack/fissure.
6. Allow for 100% re-pointing on outside including to hood and to jambs and cill.

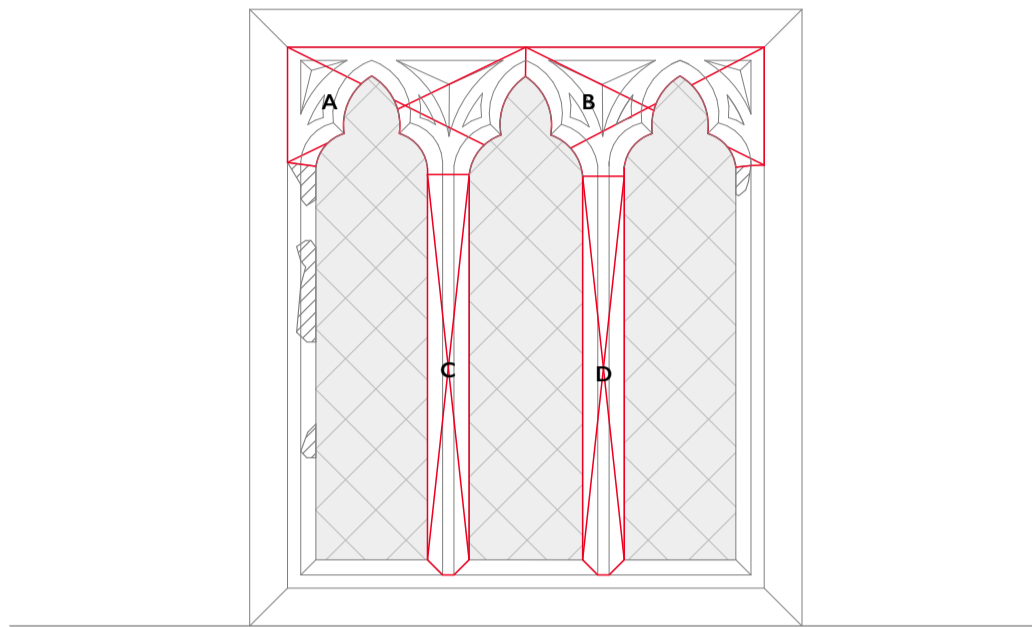
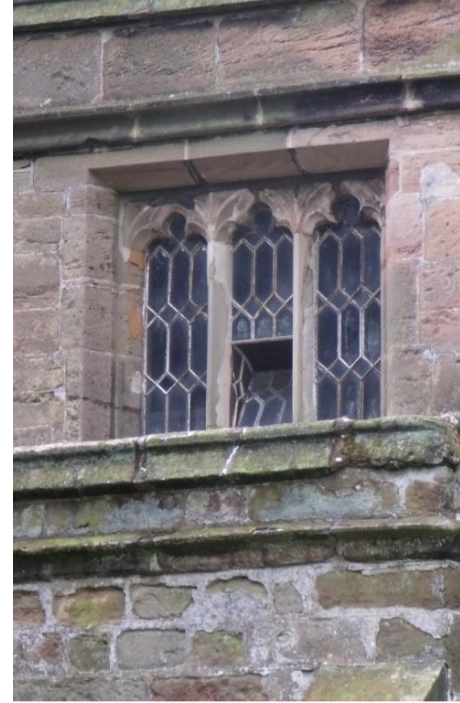
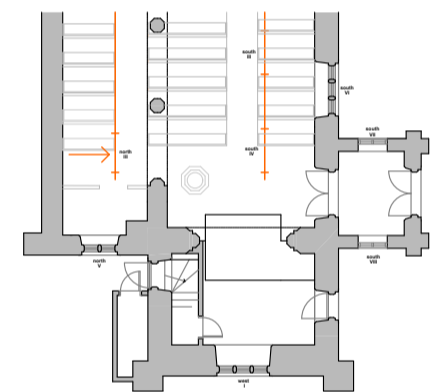
## window clerestory north III

Cast iron glazing bars to be carefully removed and repaired.

1. PROVISIONALLY replace tracery stone A to glass line. Dimensions given assume re-set on natural bed. To be re-assessed after glazing is removed - if replacement is not necessary then conservation using mortars and pinning to be undertaken and an alternative cost to be presented.
2. Tracery stone B: also provisional and as A in every regard.
3. Replace mullion C to glass line.
4. Replace mullion D to glass line.
5. Allow PROVISIONALLY an extra-over cost for providing temporary support as required and replacing mullions C and D to full depth instead of to glass line.
6. Remove old repairs and re-do in lime mortars, to jambs as indicated.
7. Allow for 100% re-pointing on outside including to hood and to jambs and cill.

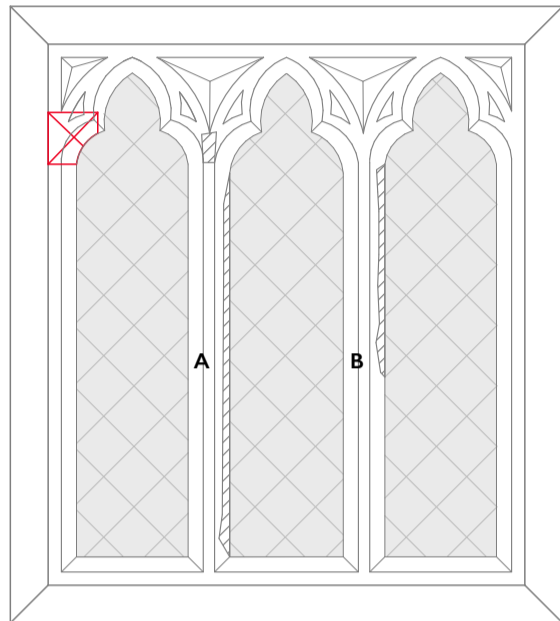
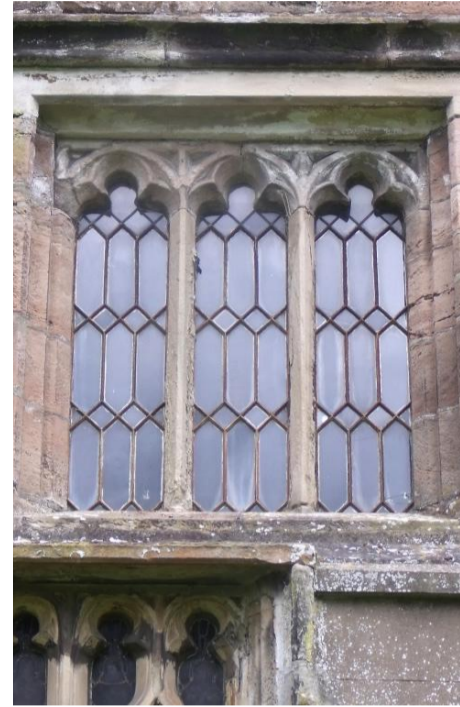
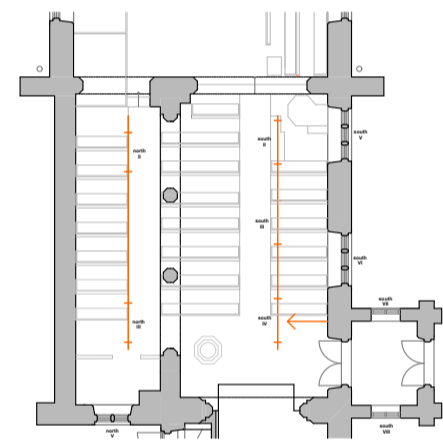
## window south II

Cast iron glazing bars to be carefully removed and repaired.

1. Make indent repair to tracery where shown, back to glass line.
2. Make lime mortar repairs to tracery and to sides of mullions, where shown.
3. Allow for 100% re-pointing on outside including to hood and to jambs and cill.

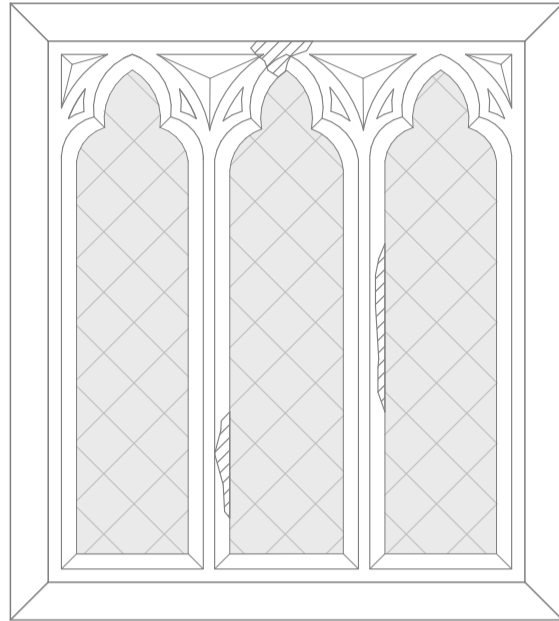
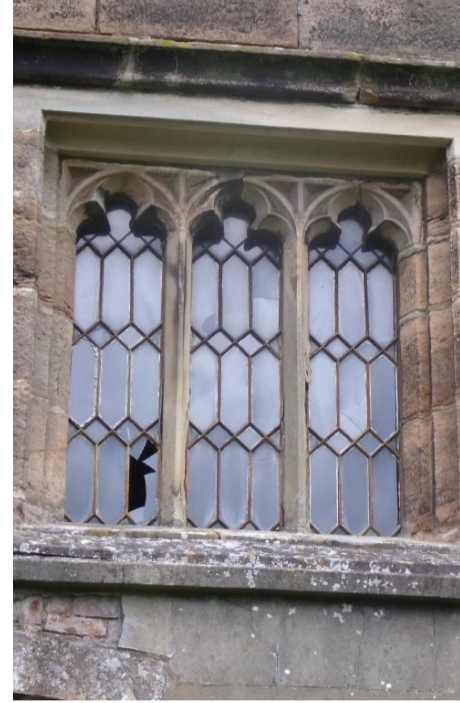
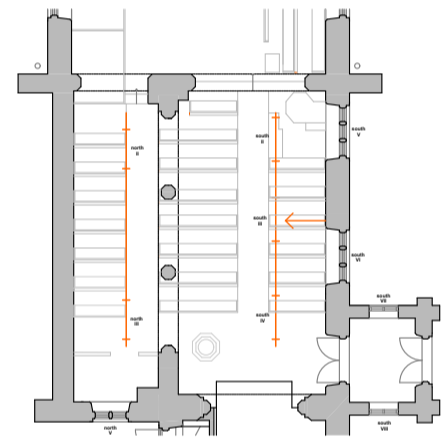
## window clerestory south III

Cast iron glazing bars to be carefully removed and repaired.

1. Make repairs in lime mortar to mullions as indicated.
2. Replace hard cement mortars to tracery including to cusps, as shown above, in lime mortar.
3. Allow for 100% re-pointing on outside including to hood and to jambs and cill.

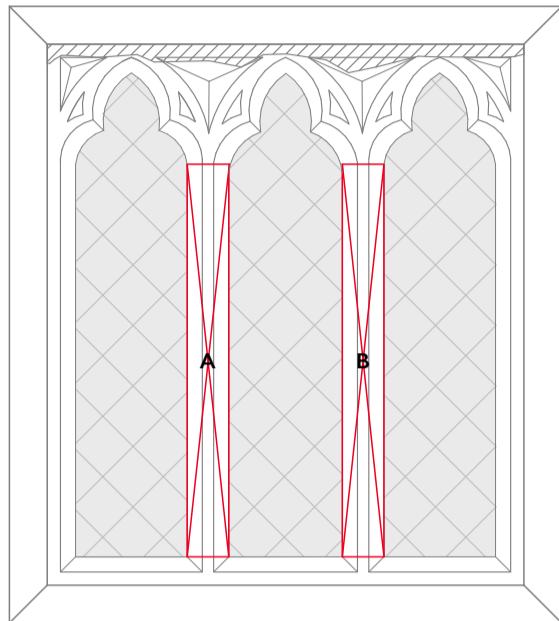
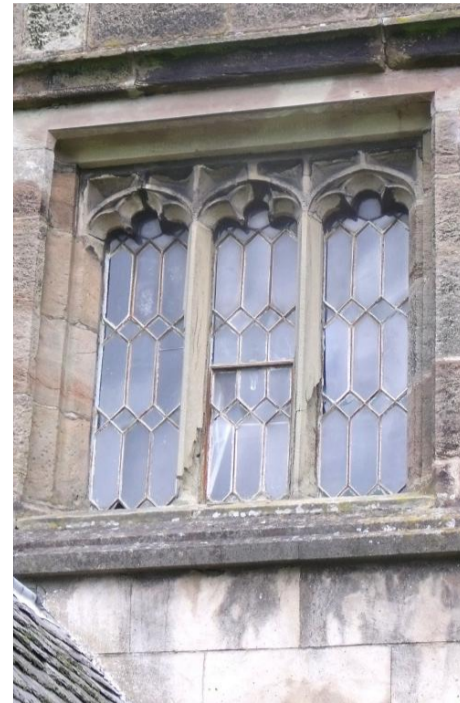
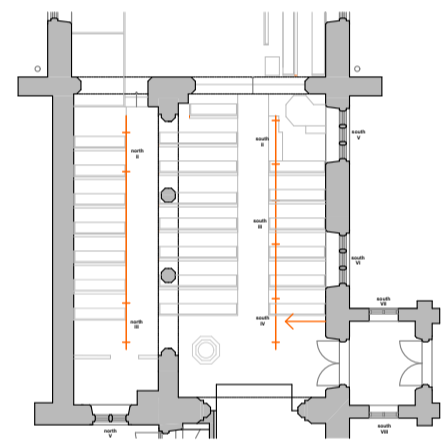
## window clerestory south IV

Cast iron glazing bars to be carefully removed and repaired.

1. Replace mullion A to glass line.
2. Replace mullion B to glass line.
3. Re-do hard cement mortar repairs to tracery as indicated above.
4. Allow for 100% re-pointing on outside including to hood and to jambs and cill.

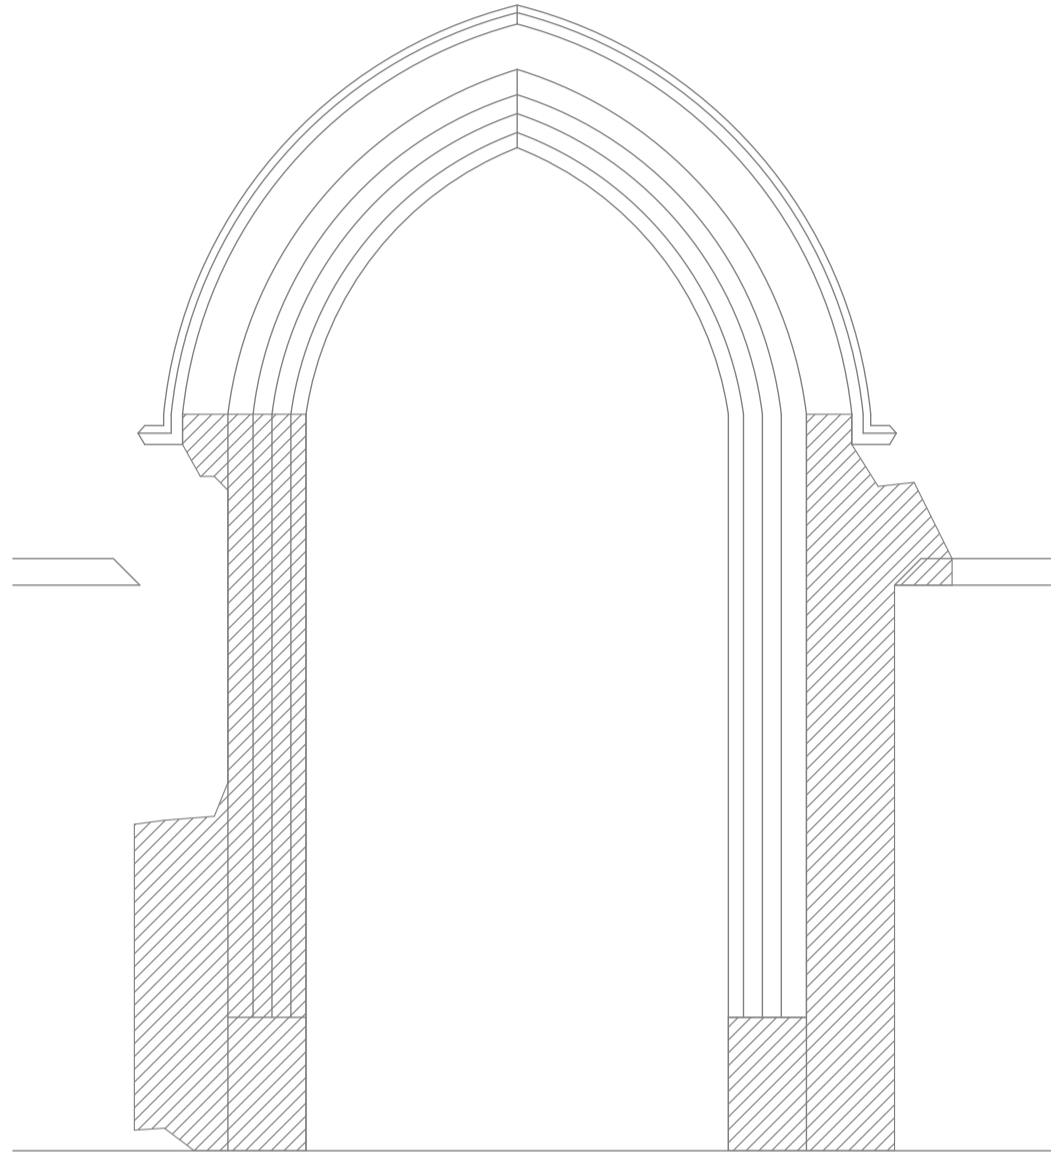
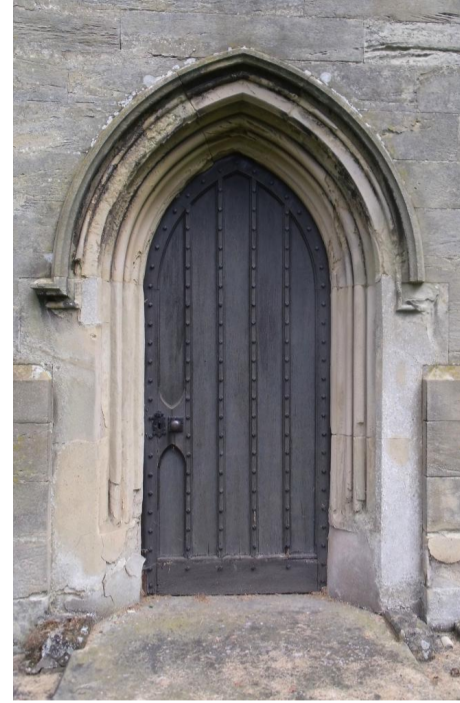
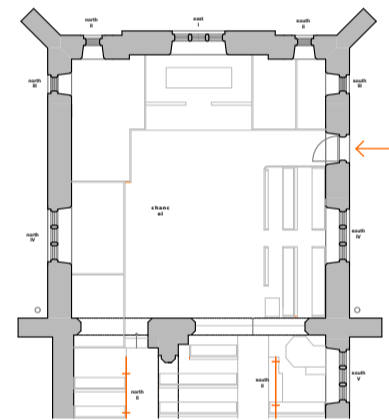
## south chancel doorway

1. The arch below the hood mould is quite badly weathered in places with disaggregation, aveolar decay and loss of original surface including lengths of roll mould. To this area generally carefully brush off loose material, consolidate locally as is necessary, carry out mortar repairs as required, and fill aveolar pockets with lime mortar. This should include the reinstatement of the missing roll mould sections.

2. To areas A and B, carefully remove the old cement repairs and re-do in lime mortar. Original joint lines in the stone should be replicated. The mother stone below may need localised consolidation to take mortar repairs.

3. Pin the fractured label stop back into place and point up the joint.
4. Allow a provisional sum of £500.00 for possible incorporation of stones at low level to the jambs into the mortar repairs in order to give these areas added stability and protection against accidental knocks.

5. Allow for re-pointing all open joints to the stone jambs, cill, arch and hood.

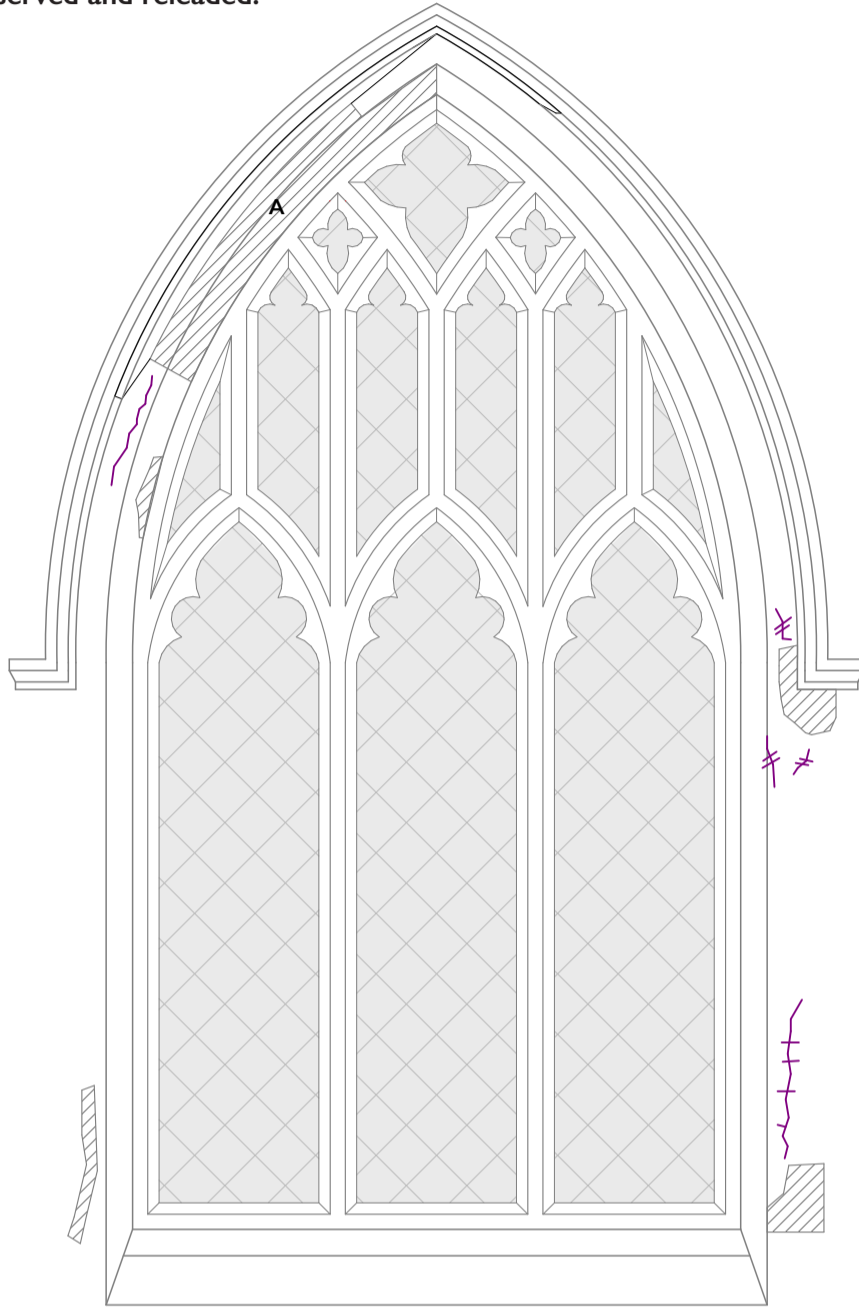
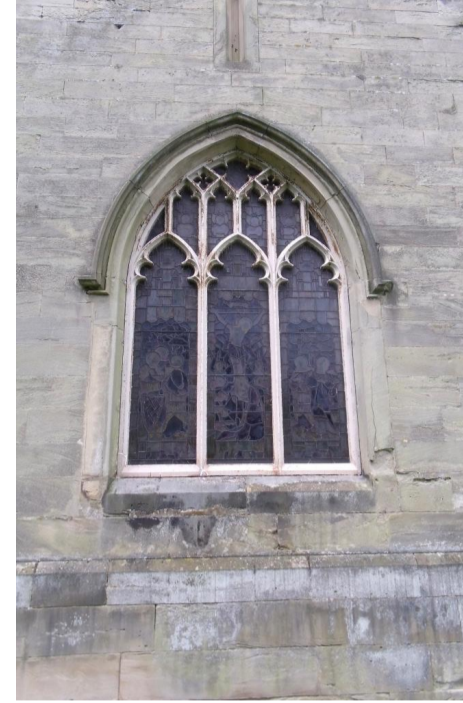
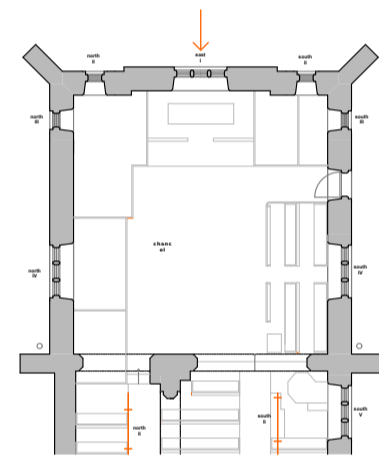
## window east I

Cast iron tracery to be carefully removed and repaired.

1. Area A is the roll mould below the hood which, for much of its length, is in very poor condition. Carefully brush off any loose material, locally consolidate, and build the mould back up to profile using lime mortar.

2. Below A, to the arch, are two large old cement repairs which are failing. Carefully remove these and re-do in lime mortar.
3. Adjacent to A, is a fissure, which needs grouting and pointing in lime mortar. Pins are not necessary here.

4. Carry out lime mortar repairs to the jambs as indicated. Note that the one on the left jamb is to consolidate the edge of an otherwise intact and sound old cement repair.

5. On the right jamb there are several fissures which need grouting and pointing up in conjunction with the insertion of stainless steel pins.
6. Remove remains of fixings from old window guard.

7. Allow for re-pointing all open joints to the stone jambs, cill, arch and hood.

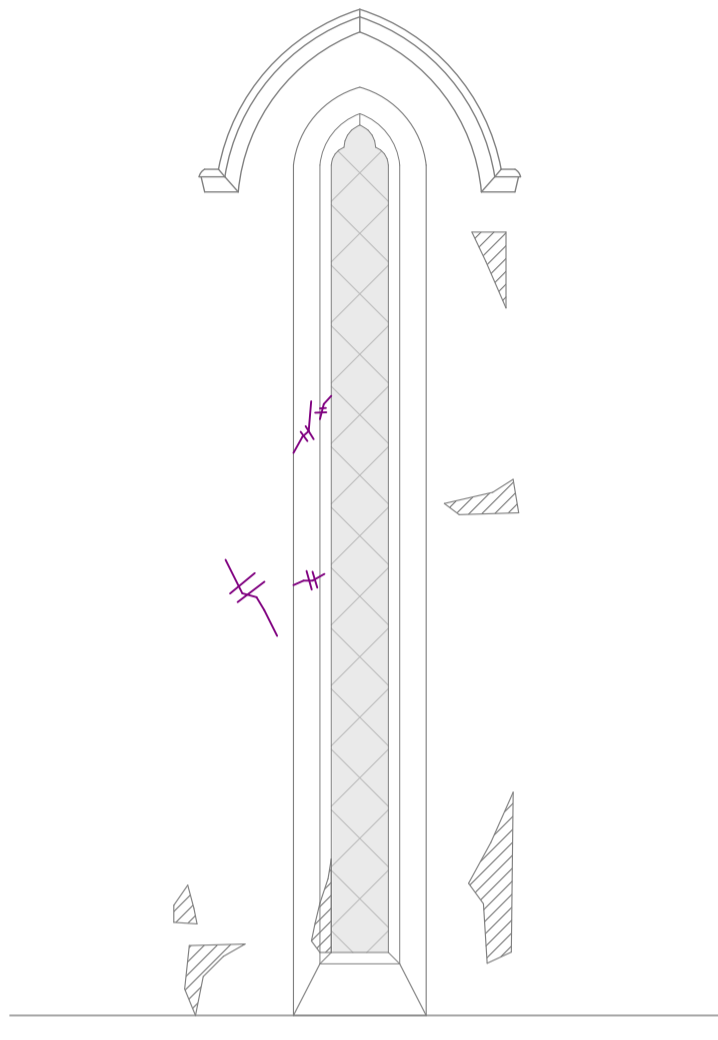
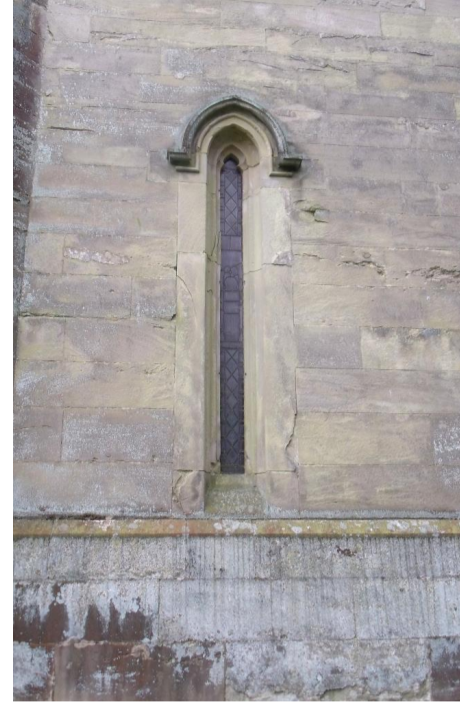
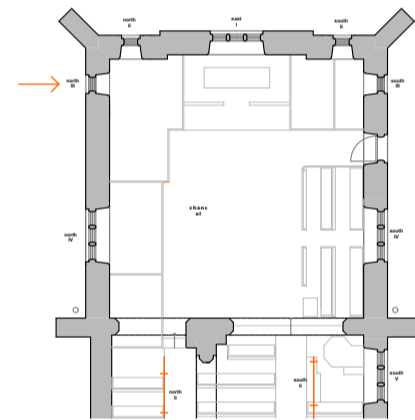
## window north III

1. The arch below the good mould is quite badly weathered with disaggregation, aveolar decay and loss of details. To this area generally carefully brush off loose material, consolidate locally as is necessary, carry out mortar repairs as required, and fill aveolar pockets with lime mortar.

2. At mid height on the left jamb there is an area of spalling stonework, possibly indicating an iron fixing behind. At this stage it would be quite disruptive to remove the stone so it is proposed that the stone is pinned, and the cracks grouted and neatly pointed up.

3. Replace failing cement mortar repairs with lime mortar repairs where shown.

4. Allow for re-pointing all open joints to the stone jambs, cill, arch and hood.

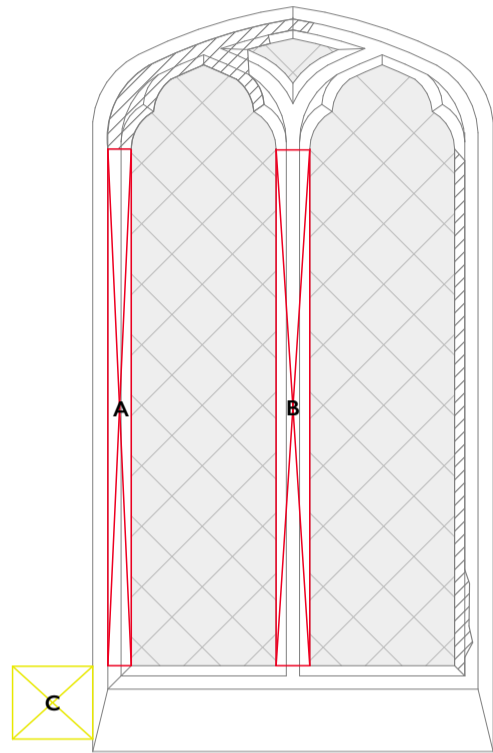
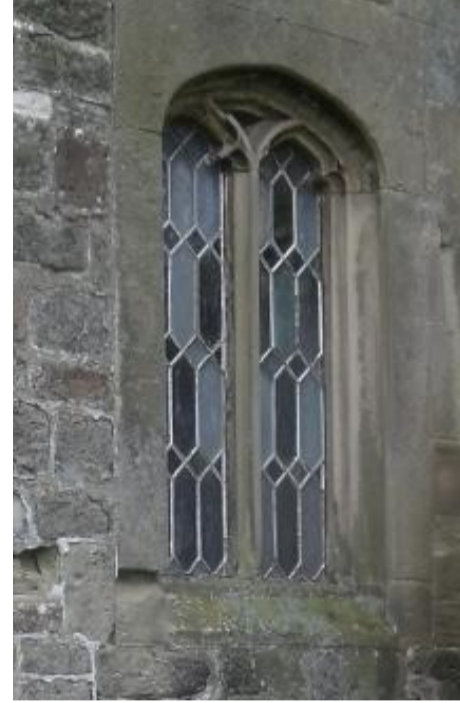
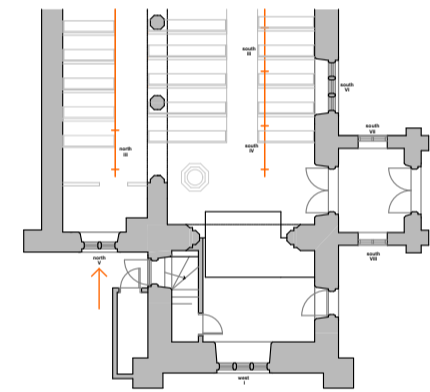
## window north V

Cast iron glazing bars to be carefully removed and repaired.

1. Replace jamb A to glass line. Note that it is proposed that the front face of the stone is retained, and that the moulded jamb reveal face is indented in to the mother stone whilst the glass is out.
2. Replace mullion B to glass line.
3. Insert new stone indent C
4. Brush down the underside of the head stone to remove loose material and build up mortar repairs to return the area shaded above to profile. Some of the background stone may require localised consolidation.
5. Allow for 100% re-pointing on outside including to hood and to jambs and cill.
6. Allow a provisional sum of £500.00 for repairs internally.

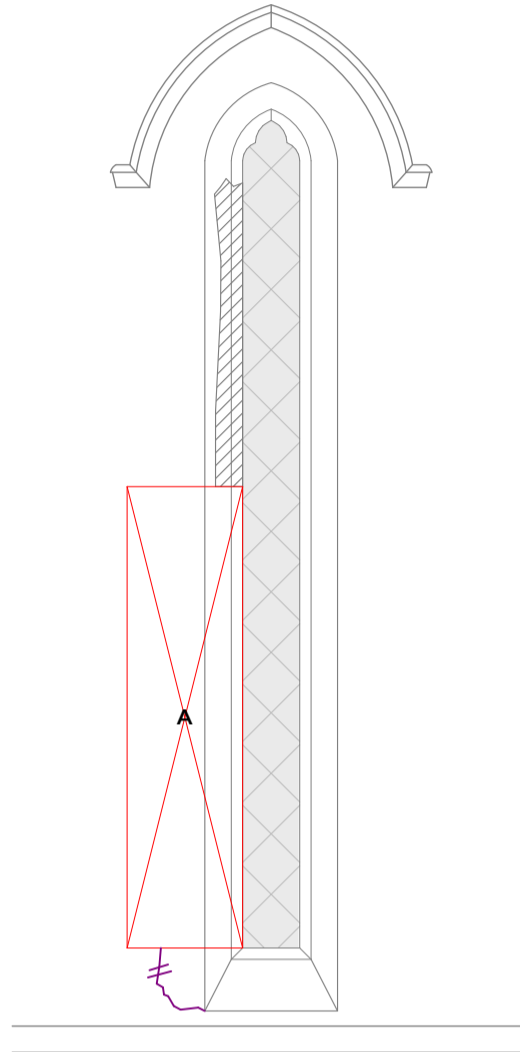
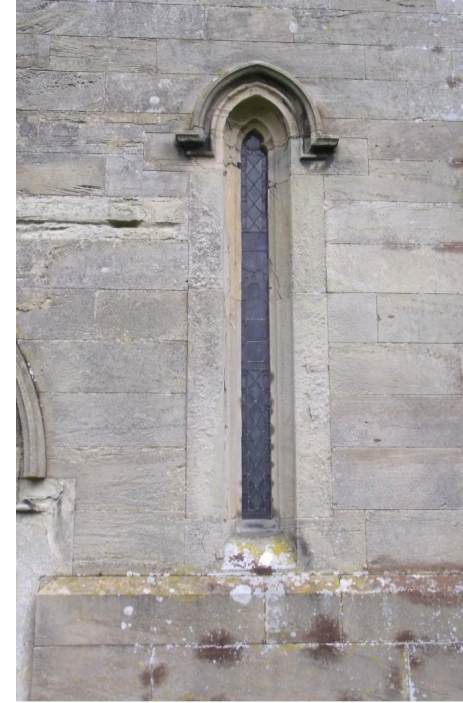
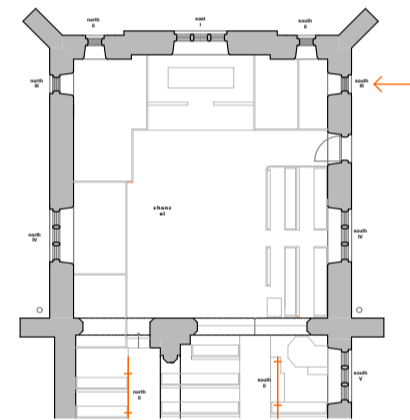
## window south III

1. The arch below the hood mould is quite badly weathered with disaggregation, aveolar decay and loss of detail. To this area generally carefully brush off loose material, consolidate locally as is necessary, carry out mortar repairs as required, and fill aveolar pockets with lime mortar.
2. Replace the failing cement repair to the left jamb with lime mortar, as shown.
3. The lower left-hand jamb stone A is badly delaminating and is significantly out of line. Being careful of the glass, replace the stone to just shy of the glass line.
4. The stone below jamb stone A, is spalling and fractured. Allow for careful pinning and grouting.
5. Allow for re-pointing all open joints to the stone jambs, cill, arch and hood.

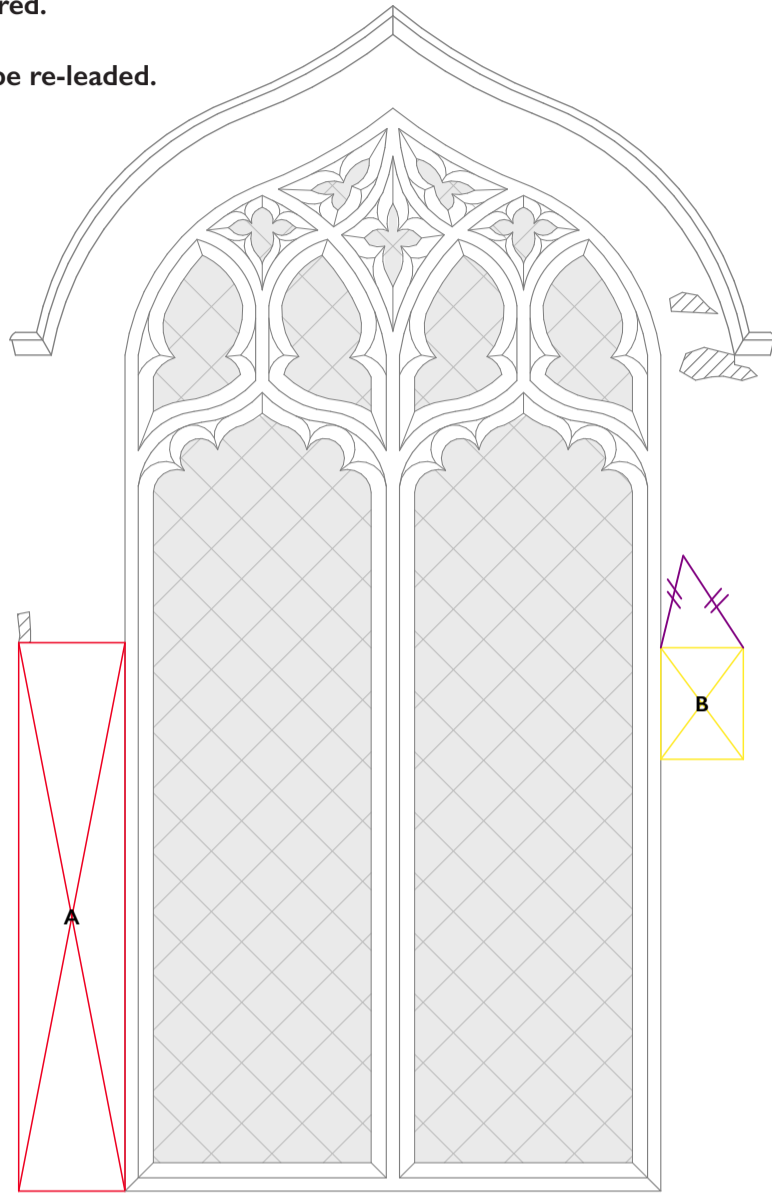
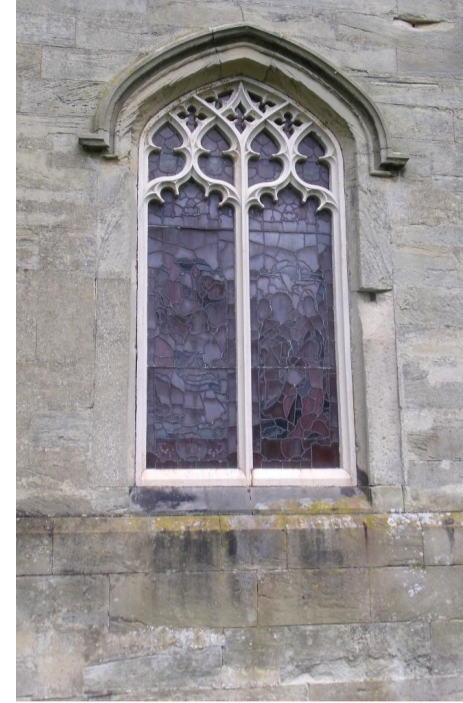
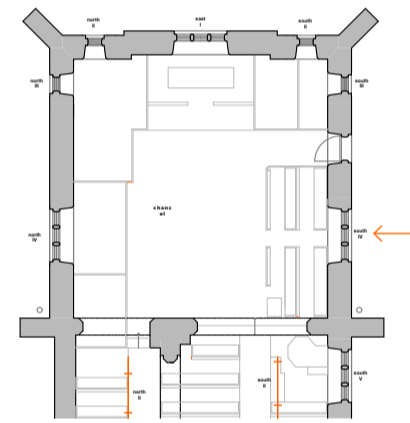
## window south IV

Cast iron tracery to be carefully removed and repaired.

1. The left-hand jamb at low level has a major spall towards the top - where there is undoubtedly an iron fixing behind, has a considerable amount of make-up in cement mortars, and is displaced out of line. Allow for it replacing it to the glass line, (A) and for removing the exposed ironwork as far as is possible.
2. Make an indent repair to the right jamb where shown, removing the exposed ironwork as far as is possible.
3. Pin spalling stone above B, where shown.
4. Replace failing cement mortar repairs with lime mortar repairs where shown.
5. Fill aveolar weathering holes to the arch.
6. Remove remains of fixings from old window guard.
7. Allow for re-pointing all open joints to the stone jambs, cill, arch and hood.

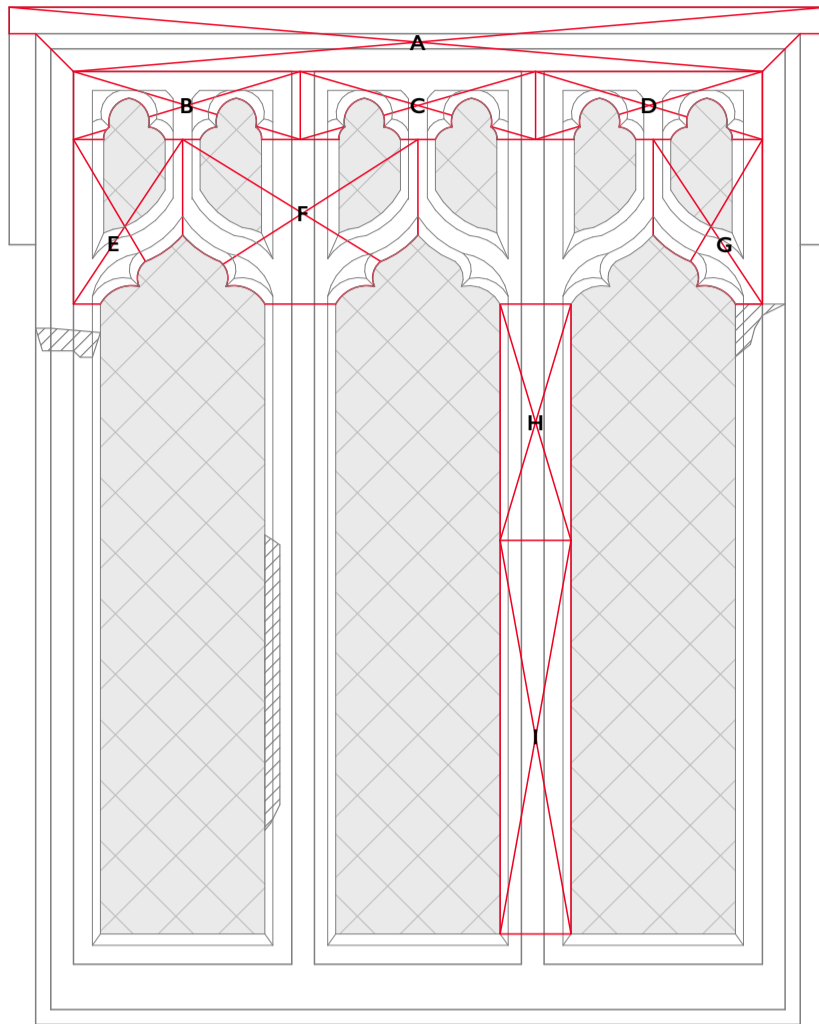
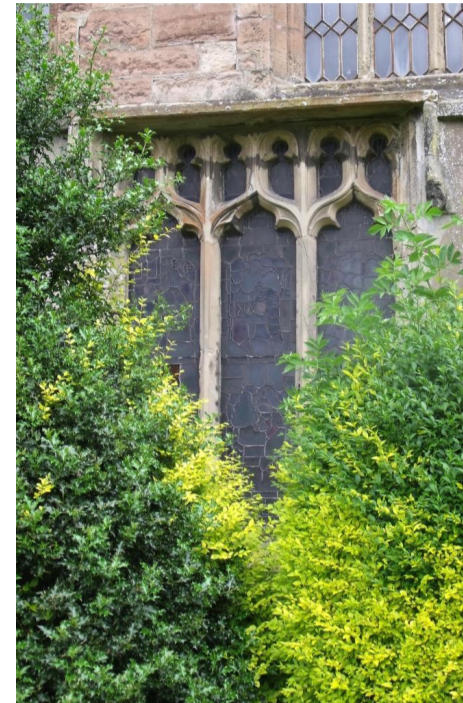
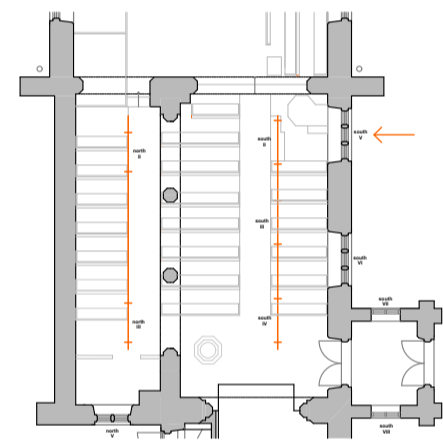
## window south VI

Stained glass to be re-leded.

1. PROVISIONALLY replace hood stone A.
2. Replace tracery stone B to glass line.
3. Replace tracery stone C to glass line.
4. Replace tracery stone D to glass line.
5. Replace tracery stone E to glass line.
6. Replace tracery stone F to glass line.
7. Replace tracery stone G to glass line.
8. Replace mullion H to glass line.
9. Replace mullion I to glass line.
10. Mortar repairs to left-hand mullion, where shown.
11. Mortar repairs to jambs, where shown.
12. Fill aveolar weathering holes to both jambs generally (not individually marked up)
13. Allow for 100% re-pointing on outside including to hood and to jambs and cill.

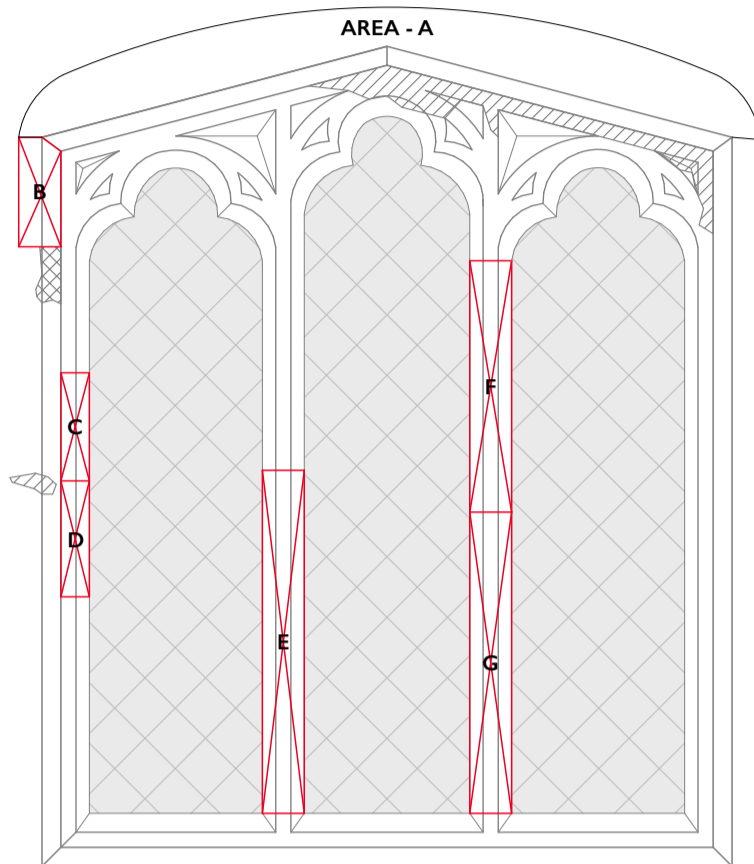
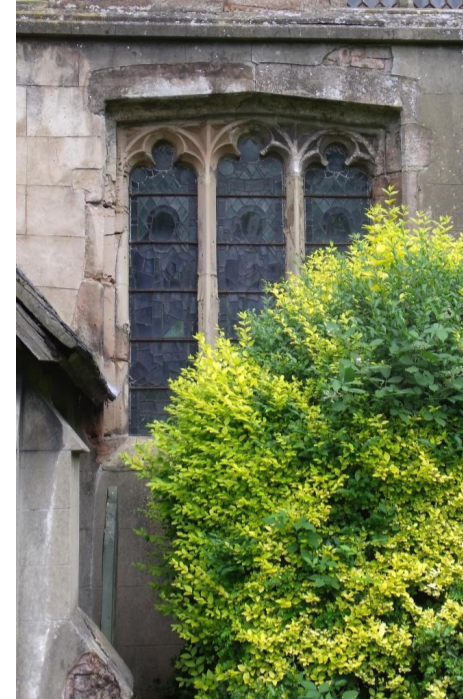
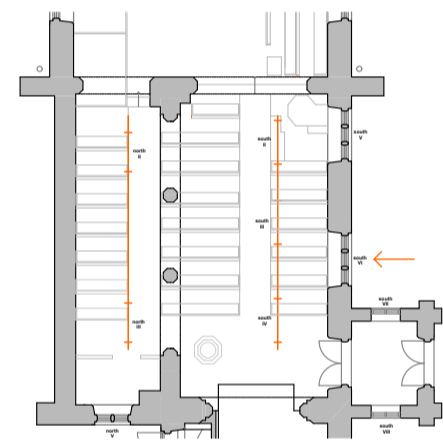
## window south VI

Stained glass to be re-leaded.

1. To area A, the underside of the window head, there are numerous old mortar (cement) surface repairs, and extensive areas of surface disaggregation and spalling. This area generally should be conserved using a combination of fine mortar repairs and consolidation.

2. Remove old repairs including hard grey cement and redo in lime mortars, to tracery, jambs and head as indicated.
3. Fill aveolar weathering holes on left-hand side where shown. Note that a spalling piece of stone just below 'B' may need pinning.

4. The tracery generally, beyond the areas highlighted for mortar repair, needs carefully brushing down to remove loose material and conserving using fine lime mortar fillets and with local consolidation.

5. Replace jamb stone B to glass line.
6. Replace jamb stone C to glass line.
7. Replace jamb stone D to glass line.
8. Replace mullion E to glass line.
9. Replace mullion F to glass line.

10. Replace mullion G to glass line.
11. Allow for 100% re-pointing on outside including to hood and to jambs and cill.

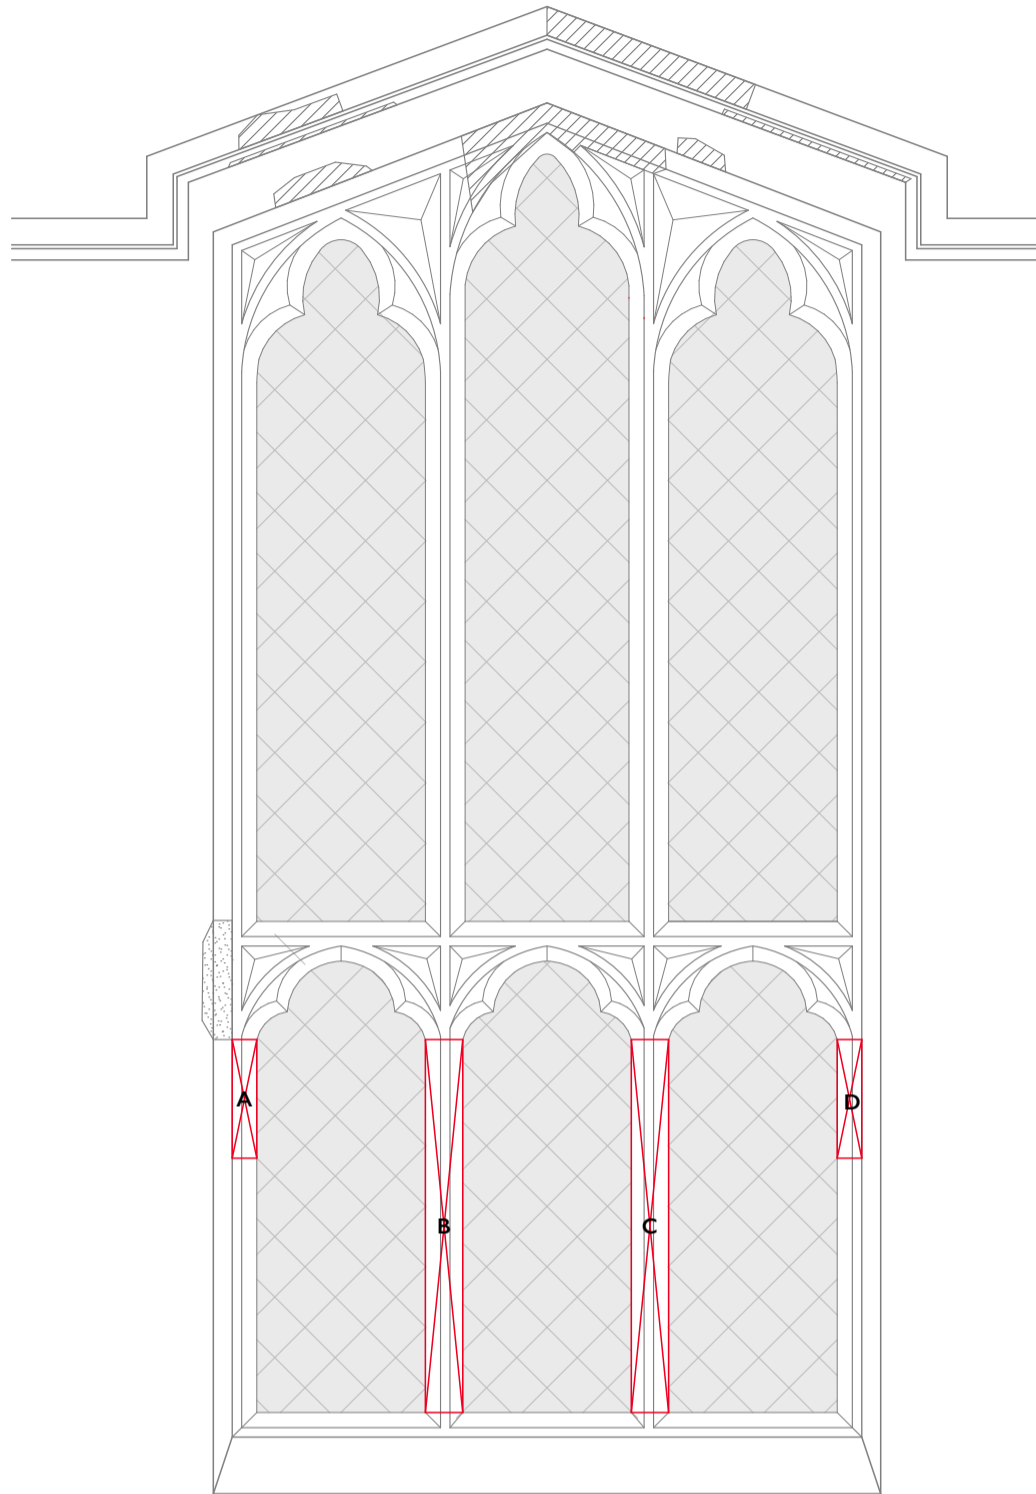
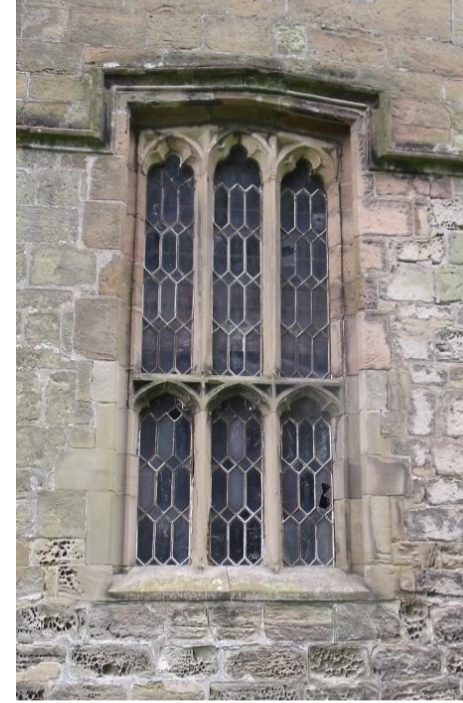
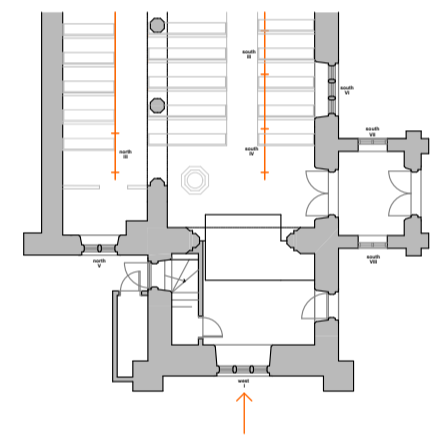
## window west I

Cast iron glazing bars to be carefully removed and repaired.

1. Replace jamb stone A to glass line.
2. Replace mullion B to glass line.
3. PROVISIONALLY replace mullion C to glass line.
4. Replace jamb stone D to glass line.
5. Deep fill and pin across three fractures in mid-level tracery, as shown.
6. Consolidate stone using fine mortar fills and micro-pins as required to area shown to left of mid-level tracery.
7. Remove old cement repairs at high level as indicated and re-do in lime mortars.
8. Allow for 100% re-pointing on outside including to hood and to jambs and cill.
9. Allow a provisional sum of £1,000.00 for repairs internally.
