# St Mary the Virgin, Congerstone Restoration and New Building Work 2019-2020

## The Nave and North Aisle Roofs

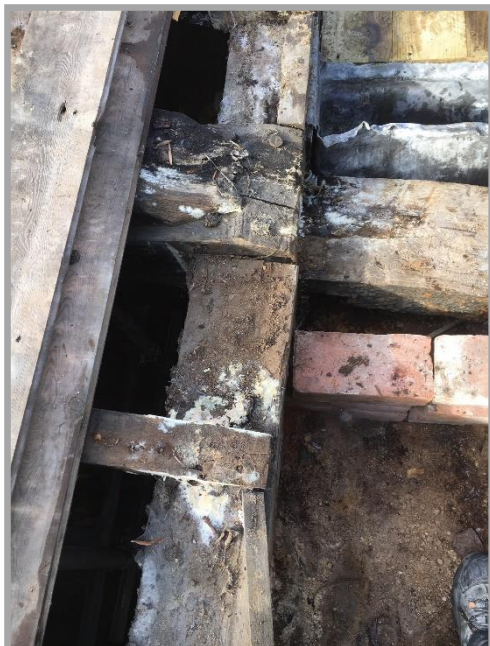
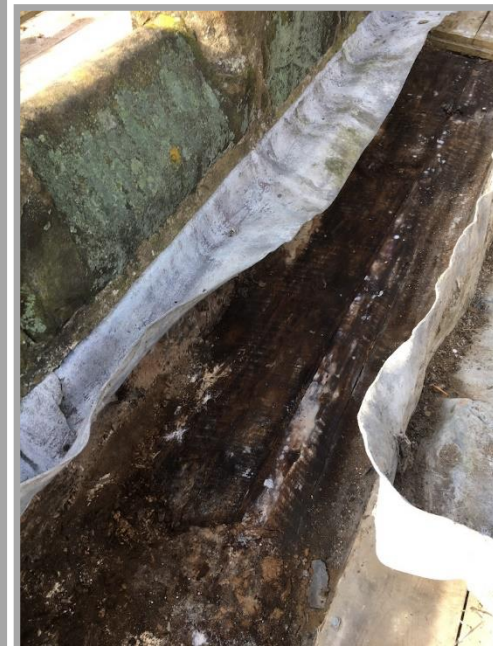
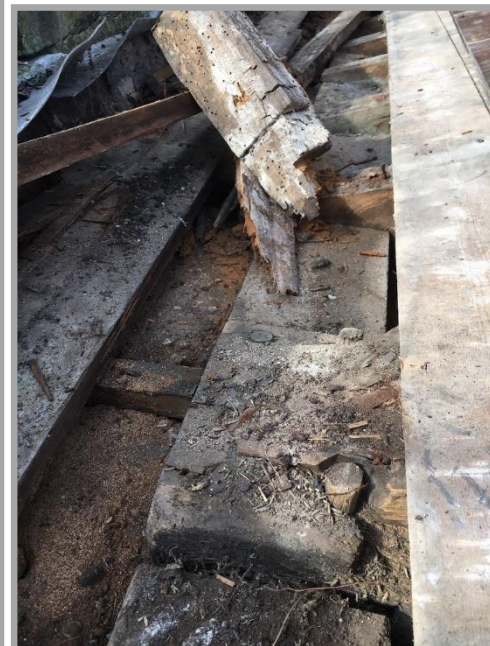
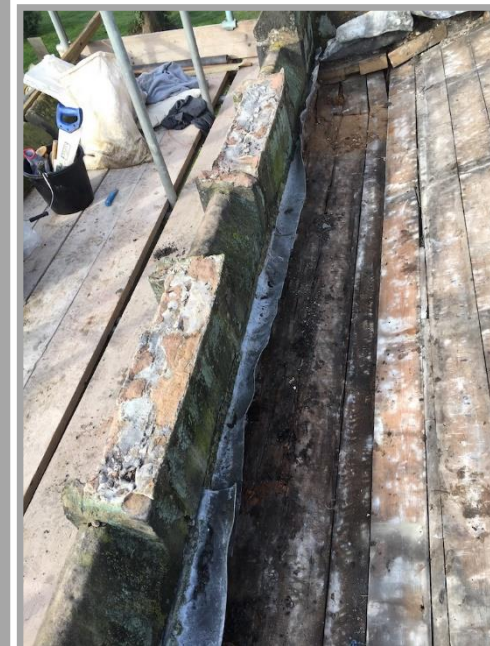
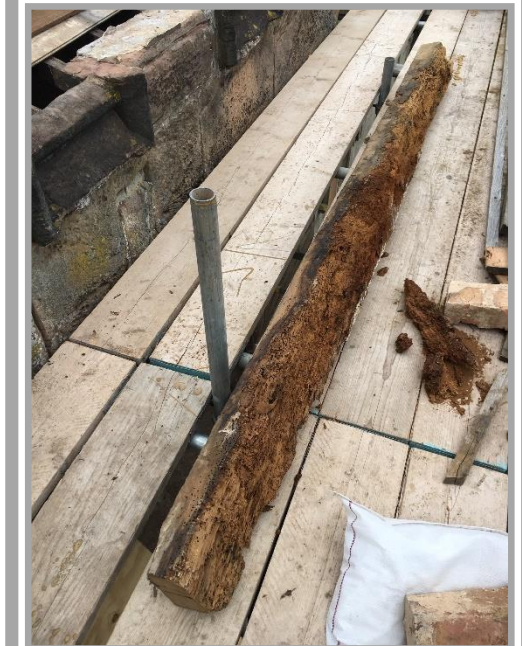
The following week, the layers of tarpaulin that had miraculously stayed intact for nearly four years were removed to reveal the rotten roof beam ends and wallplates discovered in September 2016 when the original roof works to replace the stolen lead with terne-coated stainless steel began.

This rot happened because, during restoration work in 1897, the void under the gutter boards was backfilled with sand/brick rubble and debris. This prevented air movement, and the backfill material soaked up moisture from leaks in the gutters (which had very shallow steps) and caused the beam ends and wallplates to rot.

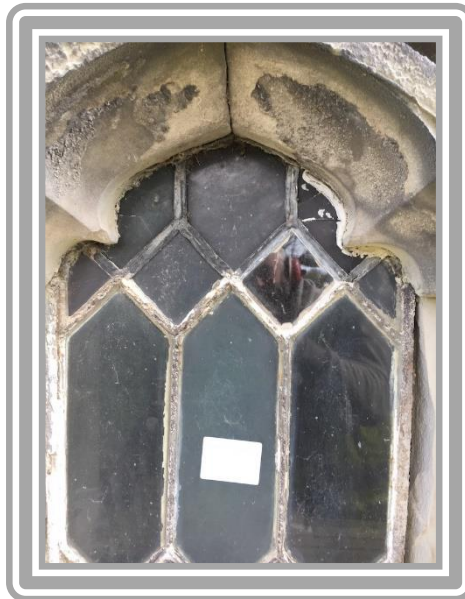
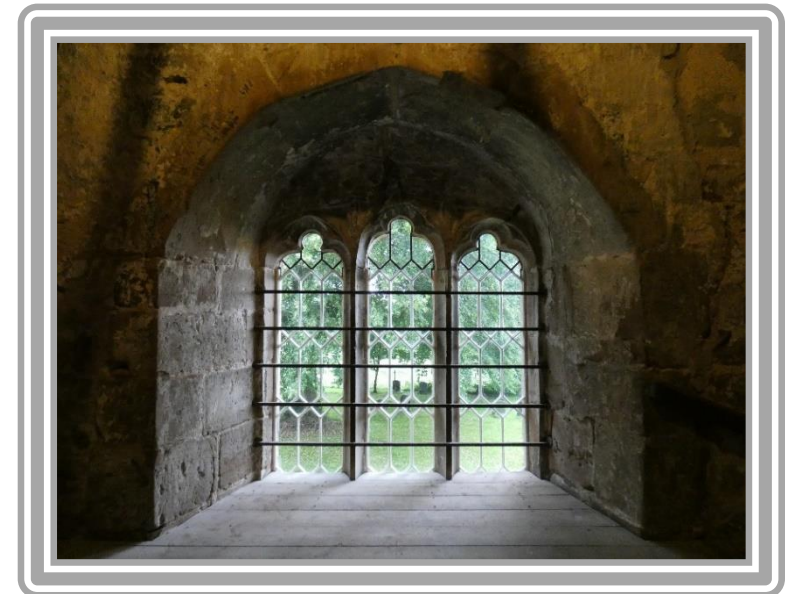
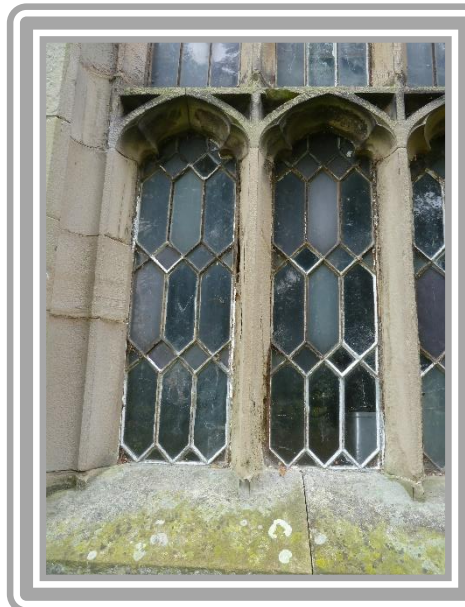
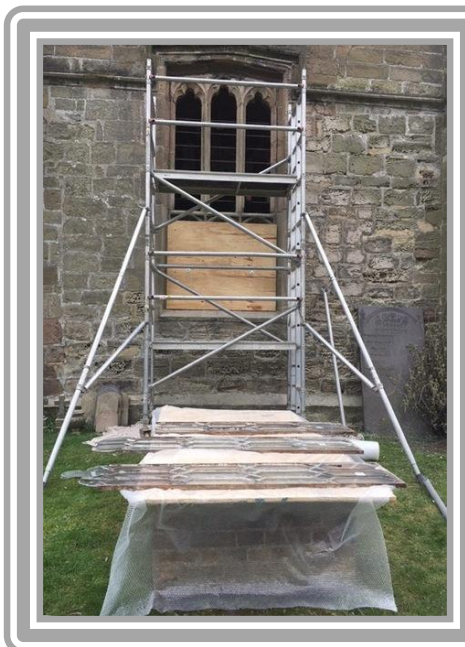
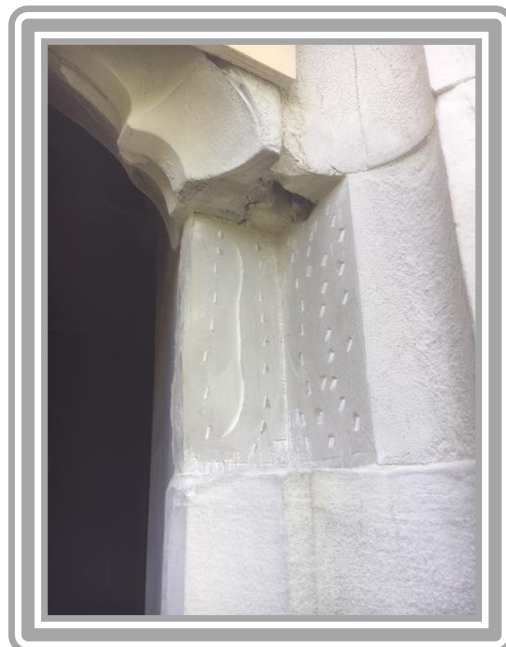
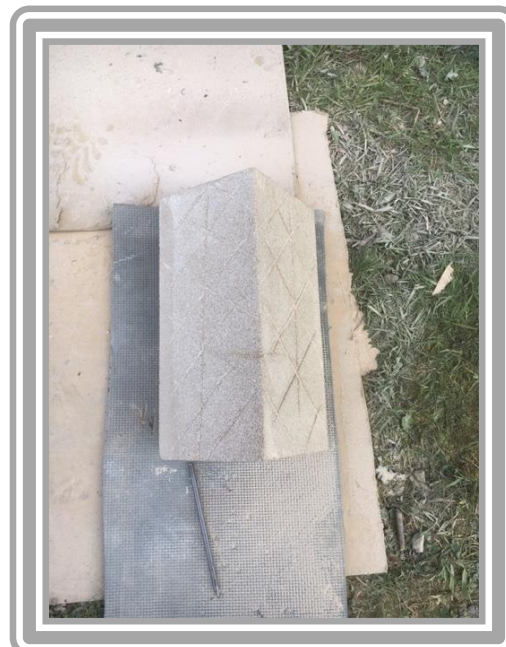
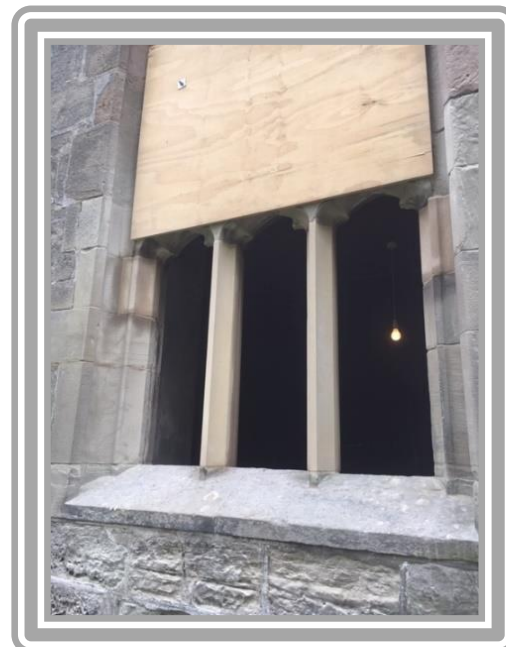
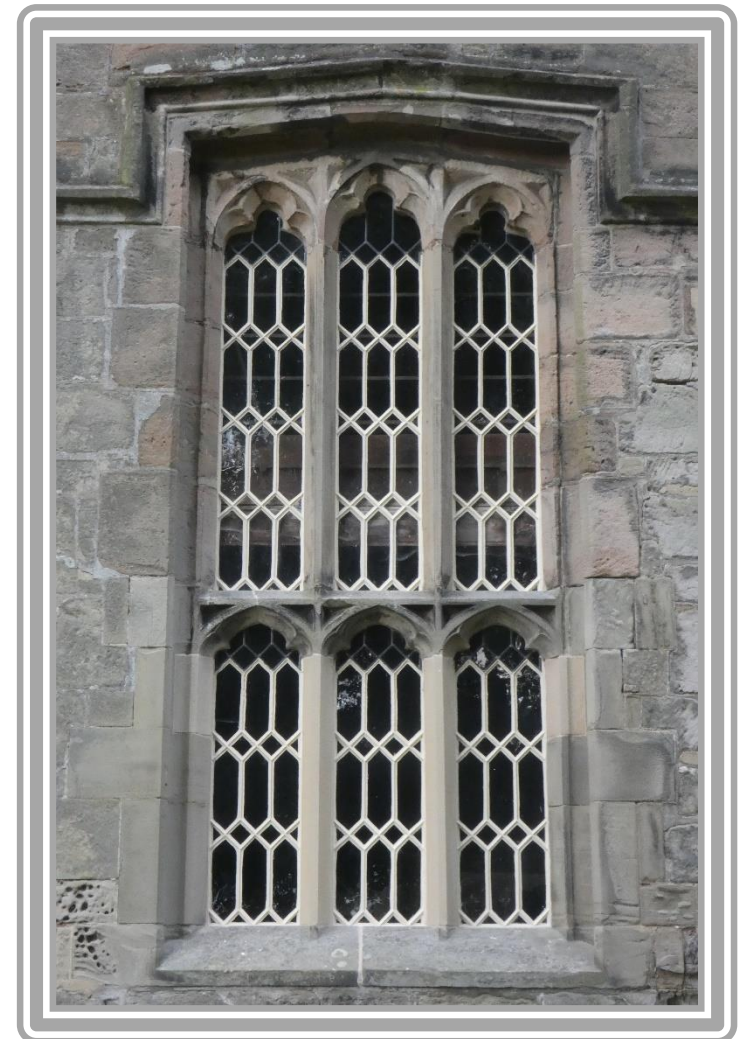
The large west window in the tower was in a very poor state of repair. The cast iron frames around each glass panel were rusty and corroded, and this had caused rust jacking to the surrounding stonework.

The six glass panels were removed from the window and taken off site. New jamb stones were then inserted into the lower stone window surrounds and the two lower mullions were replaced.

The original plan was to remove the glass carefully to allow the cast iron frames to be shot blasted and repaired before the glass panes were puttied back into their respective openings. Unfortunately, this was not possible as the glass panes were too fragile to remove intact. Therefore, after removing, cleaning and repairing the frames, the window panels were reglazed with new glass before they were put back into their stone surrounds.

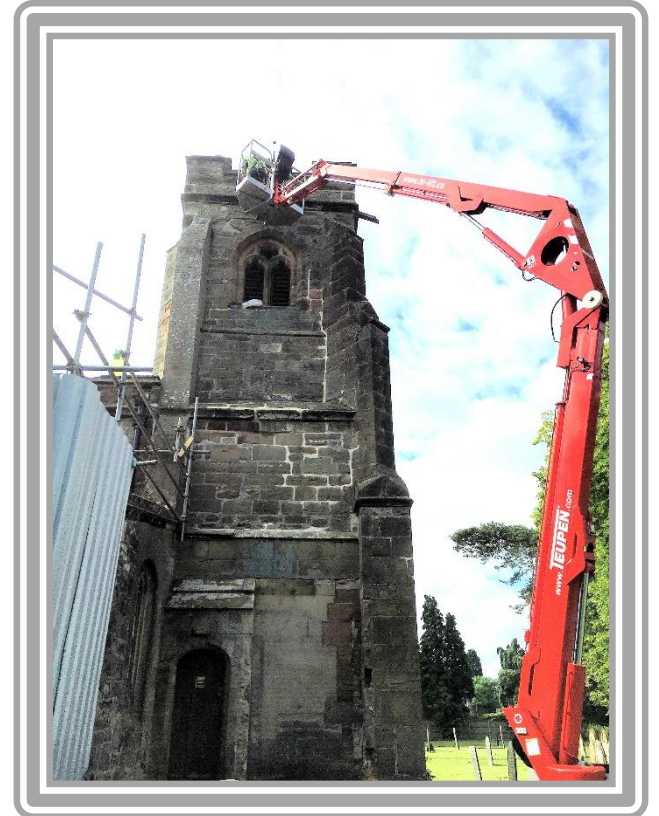
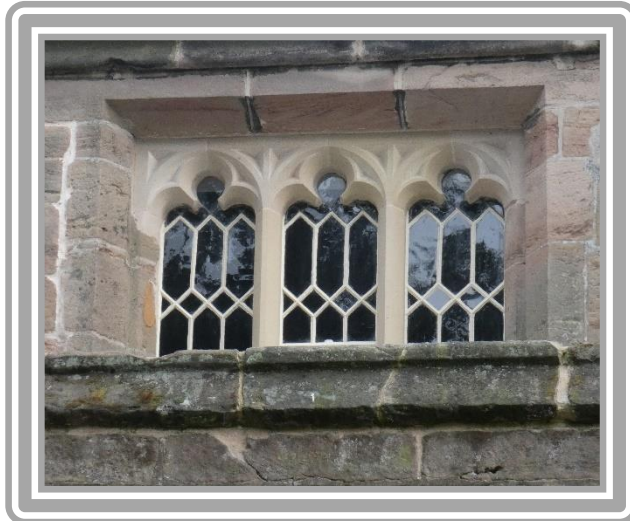
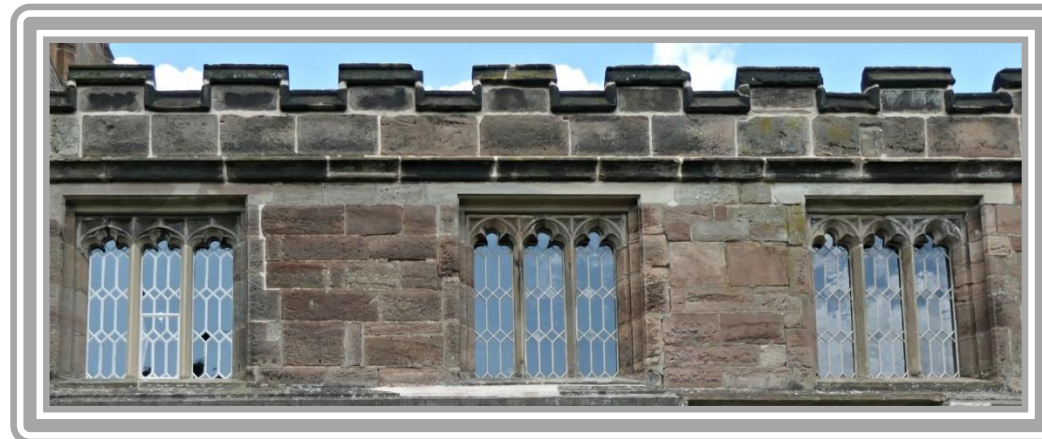
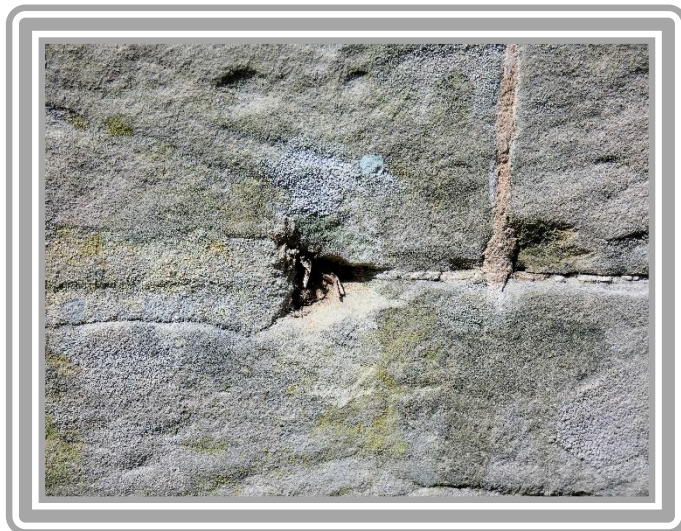
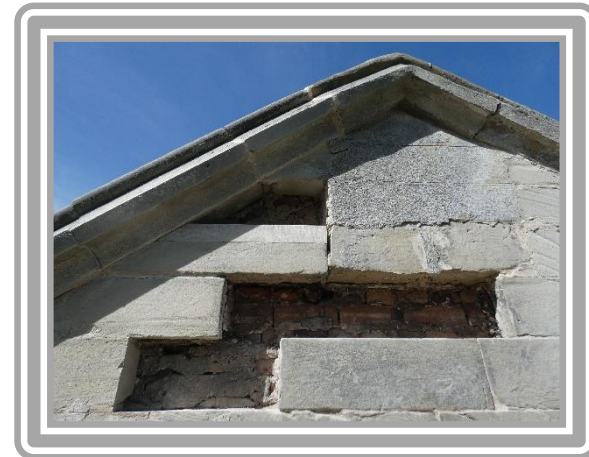
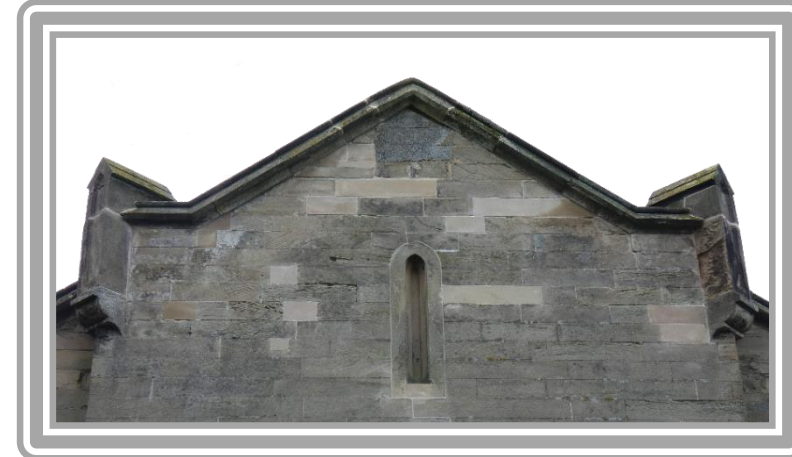
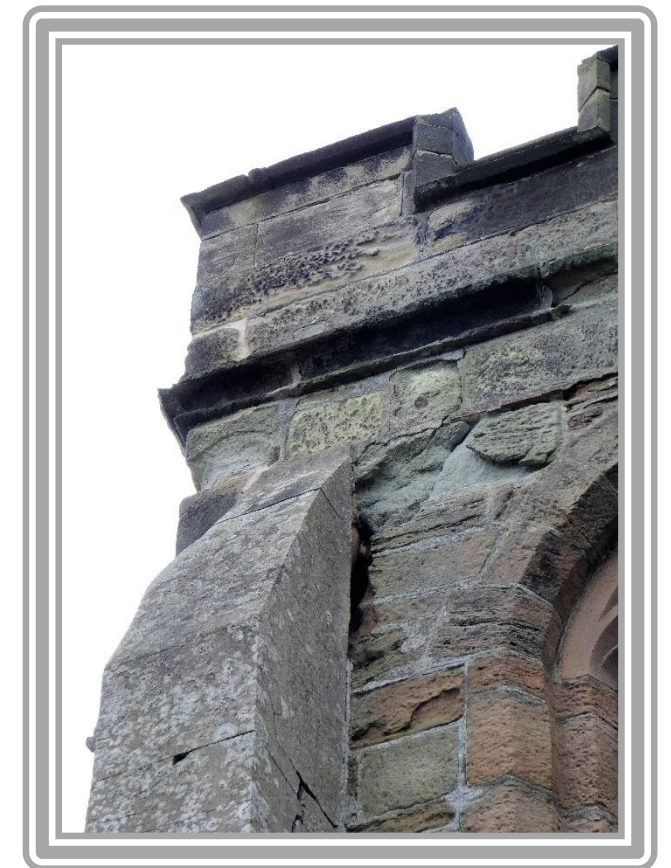
Other stonework repairs were to the chancel walls where cramps had caused the stone to shatter, and a stone-tile repair to the chimney on the side of the tower using a cherry picker for access.

As with the tower window, the glass panels in their cast iron frames were removed intact from each of the two north and three south clerestory windows. The frames were shot blasted, repaired and reglazed with new glass off site. In the meantime, the stone window tracery and two stone mullions were replaced in one of the two north clerestory windows and two stone mullions were replaced in one of the south clerestory windows.

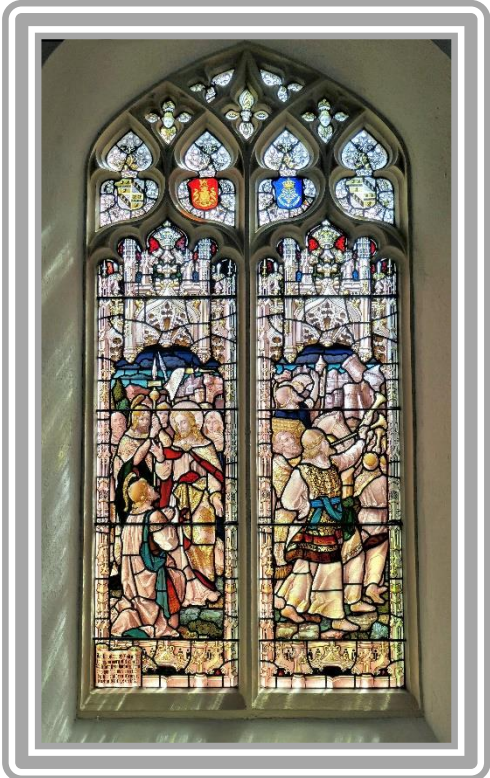
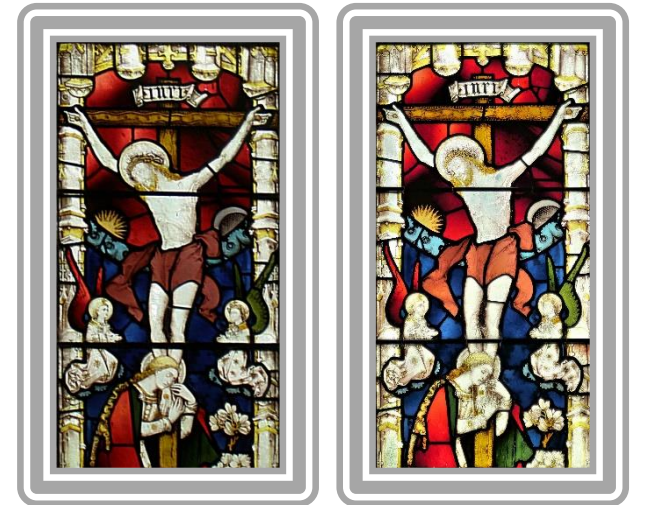
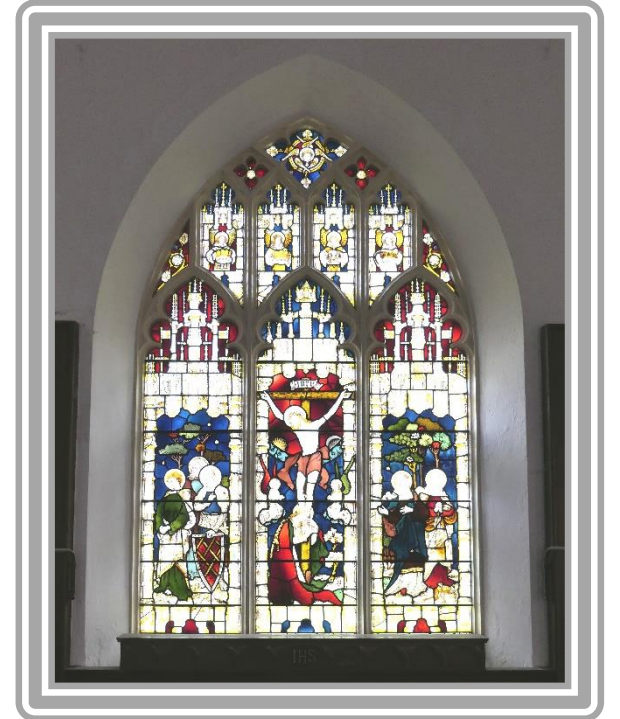
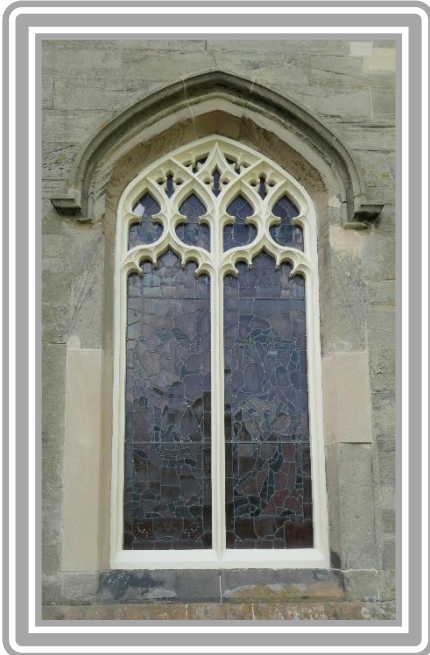
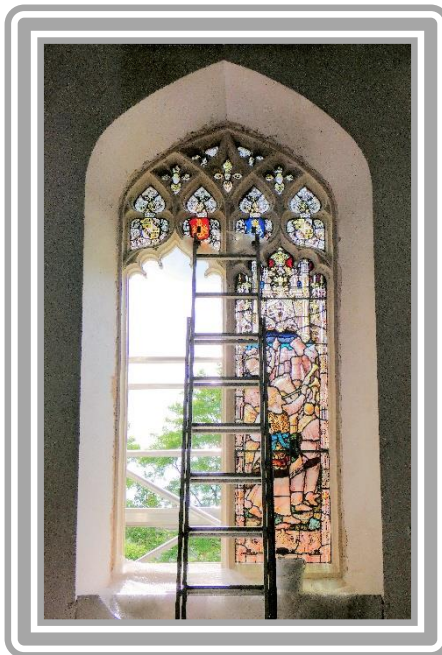
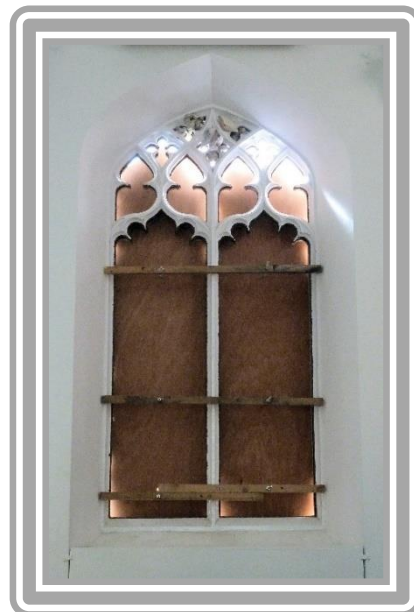
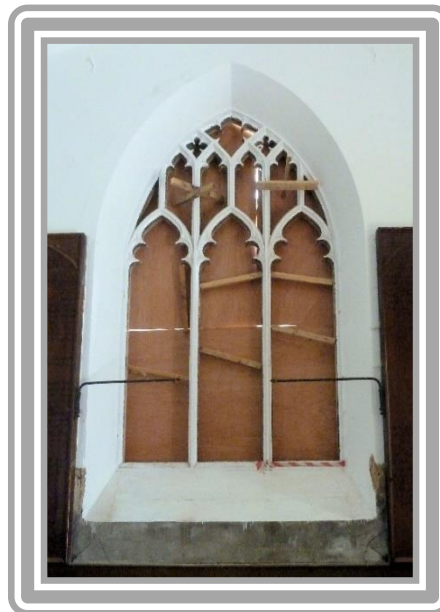
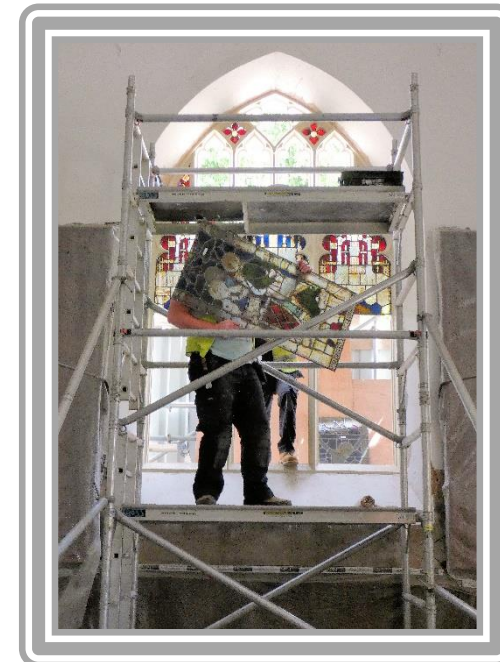
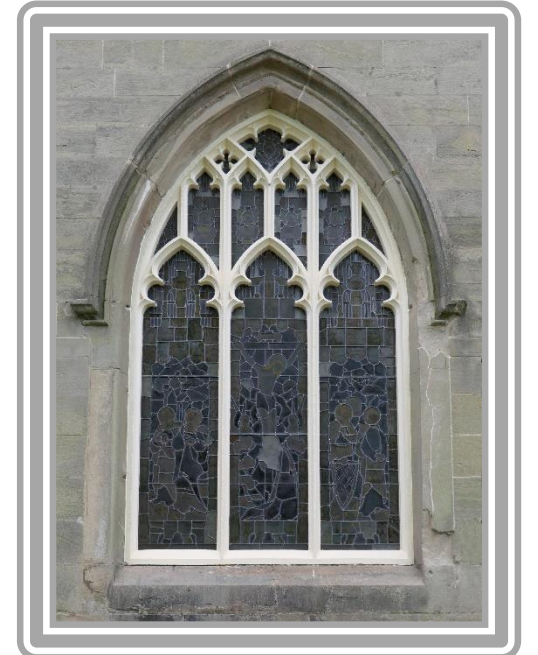
The large stained glass windows in the chancel are unusual because the jambs, mullions and tracery housing the leaded stained glass panels are made of hollow cast iron and the frames are built into the surrounding brickwork. As cutting out the frames would have been too destructive to the stonework, the internal plaster surrounds were cut back to allow the rusted edges of the frames to be treated and the cracks to be welded in-situ.

The stained glass panels in the east and south chancel windows were removed and taken off site to the Ark Stained Glass and Leaded Lights Ltd workshops. Here the panels were dismantled, re-leaded, cleaned and re-painted. The window paint was 'conserved' rather than 'restored'. So, only significant details such as the faces of the figures were added. One of the lovely results of this work was that in the large chancel window above the altar, Jesus has had his eyes restored!

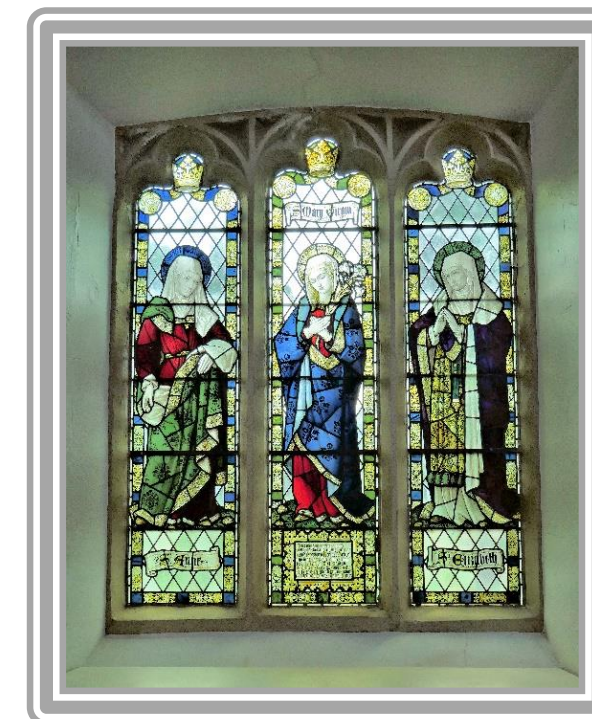
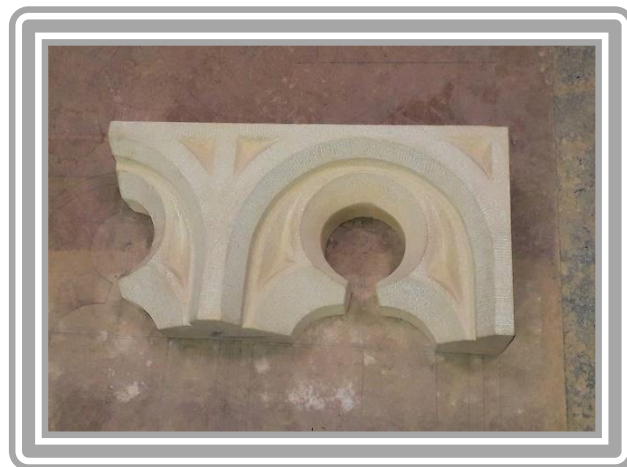
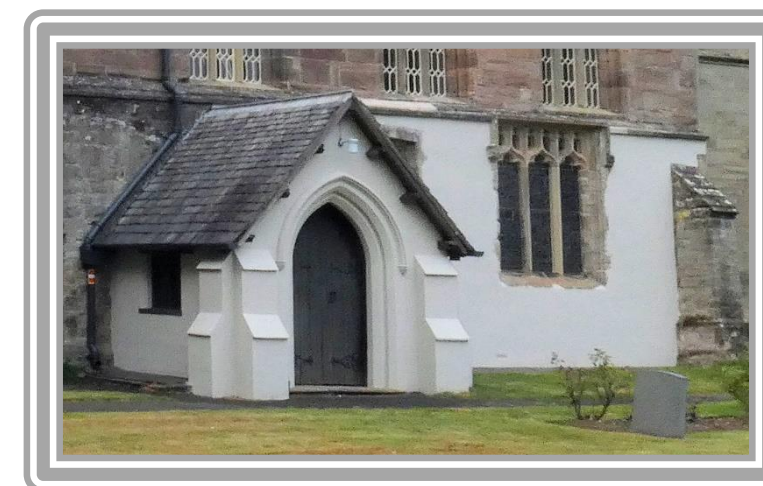
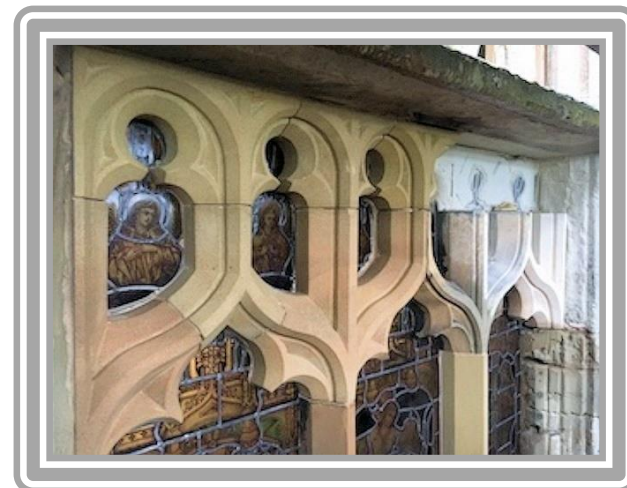
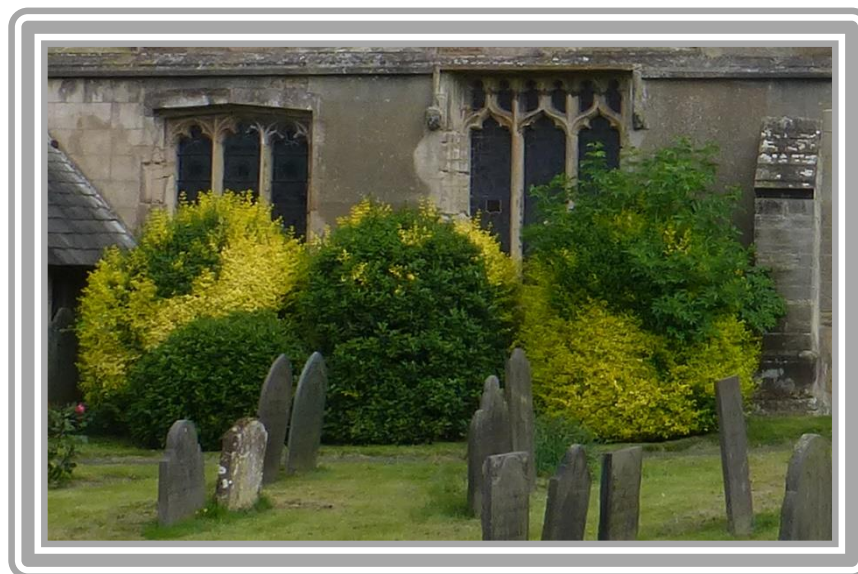
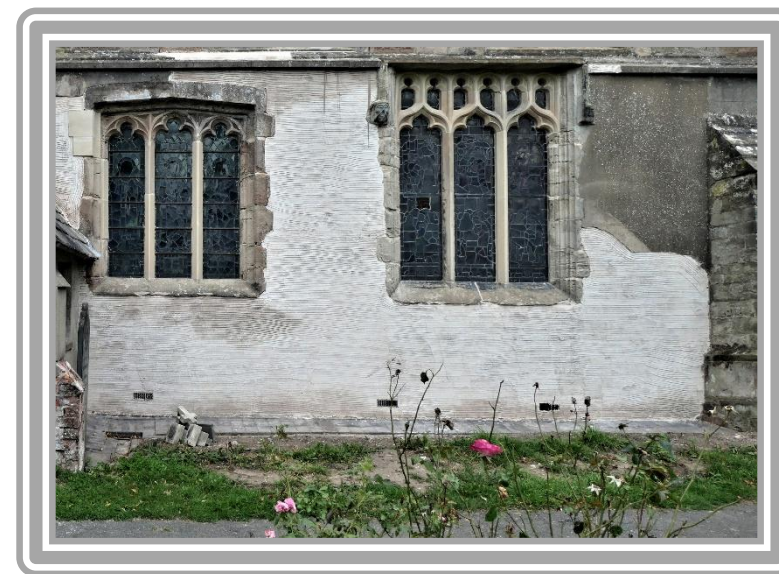
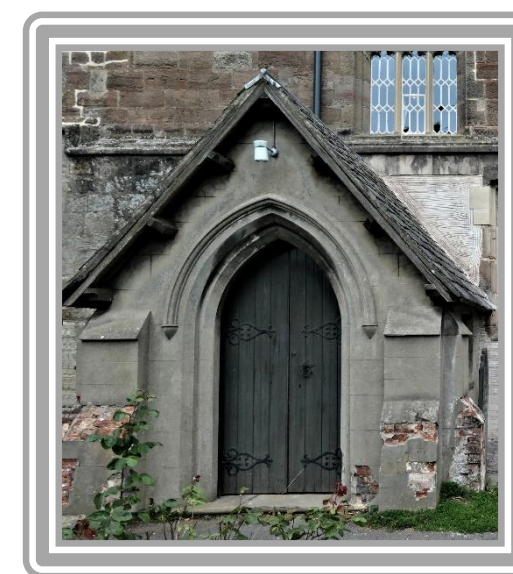
The cracked render on the nave and south porch walls was removed, new lime wash render was applied and the walls painted. New guttering and downpipes were attached to the porch to reduce future damage to the new render.

Unlike the chancel stained glass windows, the windows in the south aisle (*Sheep & Goats Window*) and nave (*Three Saints Window*) have stone surrounds, mullions and tracery. The outside sections of 3 of the 4 mullions were replaced. Damaged areas of the tracery in the south aisle window were repaired by inserting intricately carved stone sections matching the original stonework.
