# St Mary the Virgin, Congerstone Restoration and New Building Work 2019-2020

## The Nave and North Aisle Roofs

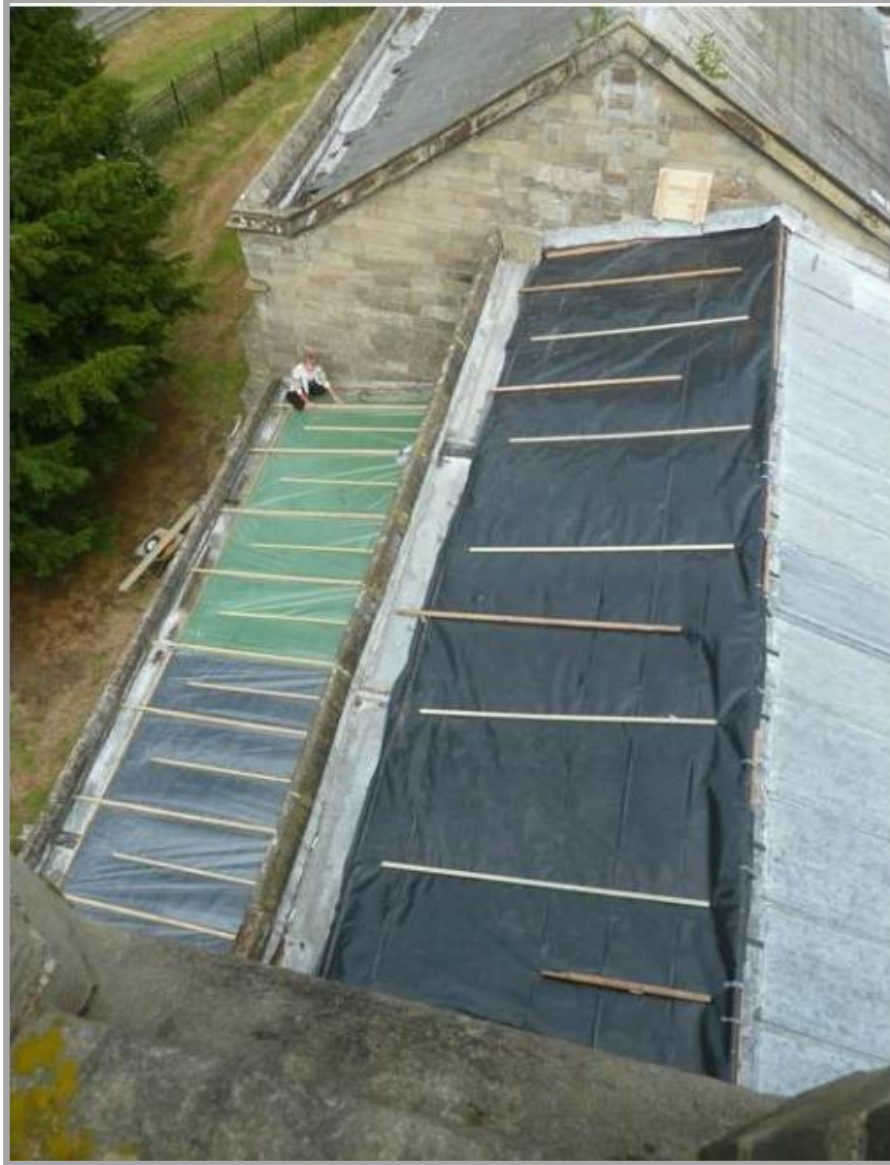
The following week, the layers of tarpaulin that had miraculously stayed intact for nearly four years were removed to reveal the rotten roof beam ends and wallplates discovered in September 2016 when the original roof works to replace the stolen lead with terne-coated stainless steel began.

This rot happened because, during restoration work in 1897, the void under the gutter boards was backfilled with sand/brick rubble and debris. This prevented air movement, and the backfill material soaked up moisture from leaks in the gutters (which had very shallow steps) and caused the beam ends and wallplates to rot.

Before replacing the main beam ends in the nave and north aisle roofs, each beam was supported internally with an acrow prop. The rotten beam end was then cut out and a new oak end piece was inserted using a mortise and tenon joint before metal flitch plates were bolted each side over the joints for additional strengthening. Finally, the flitch plates were painted dark brown so that they are barely visible in the inside of the church.

New wallplates were installed, the ends of the rotten rafters and the rotten roof boards were replaced, new gutter supports were crafted and terne-coated stainless steel gutters were inserted.

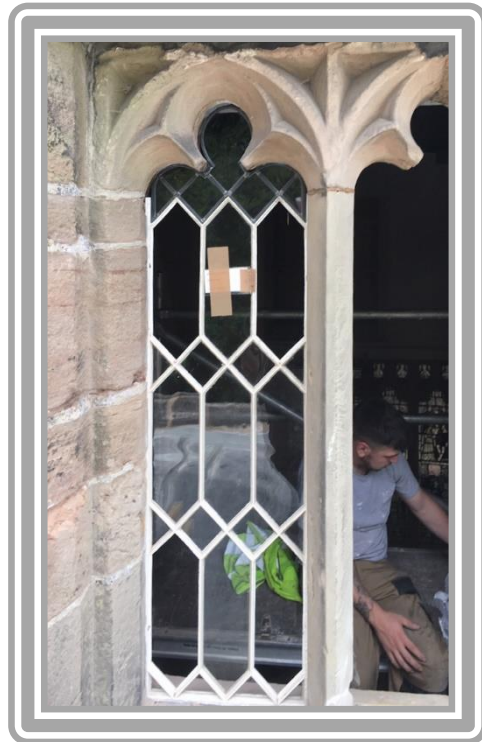
Other stonework repairs were to the chancel walls where cramps had caused the stone to shatter, and a stone-tile repair to the chimney on the side of the tower using a cherry picker for access.

As with the tower window, the glass panels in their cast iron frames were removed intact from each of the two north and three south clerestory windows. The frames were shot blasted, repaired and reglazed with new glass off site. In the meantime, the stone window tracery and two stone mullions were replaced in one of the two north clerestory windows and two stone mullions were replaced in one of the south clerestory windows.

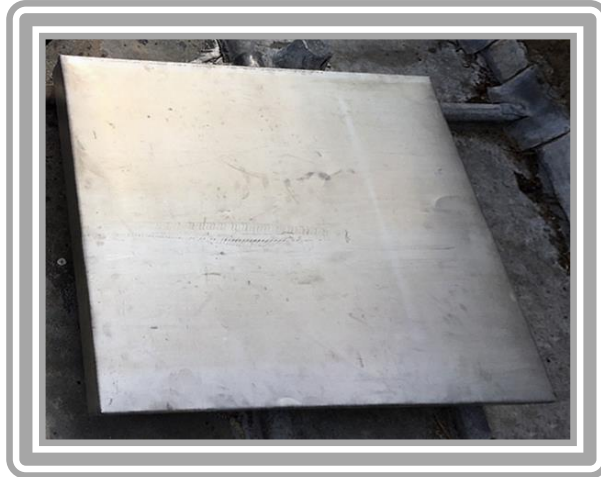
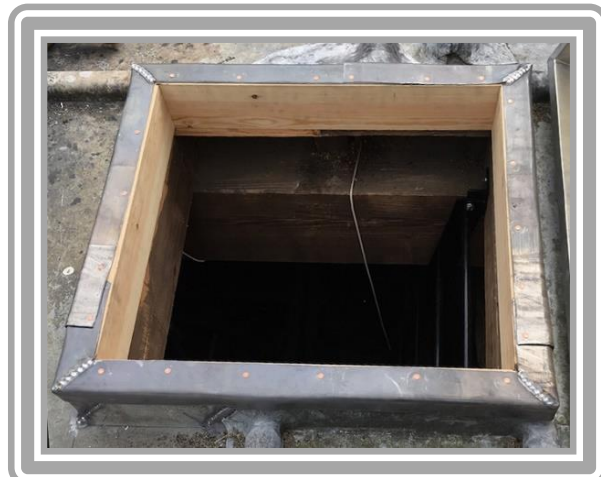
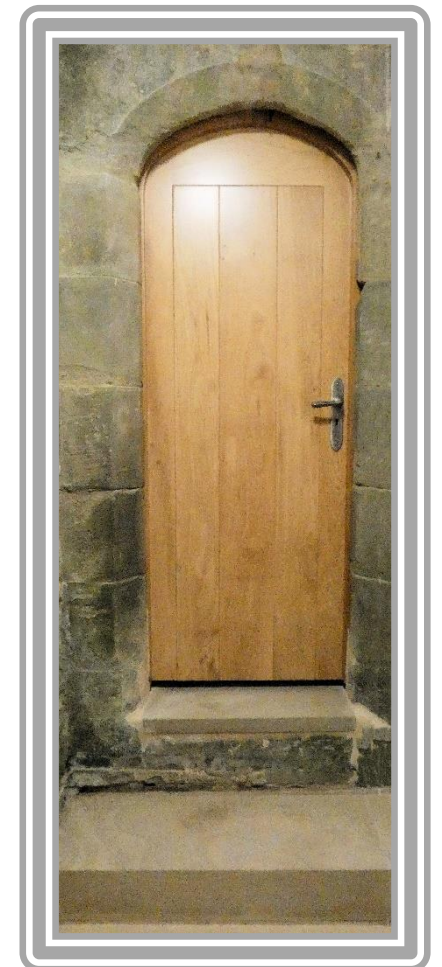
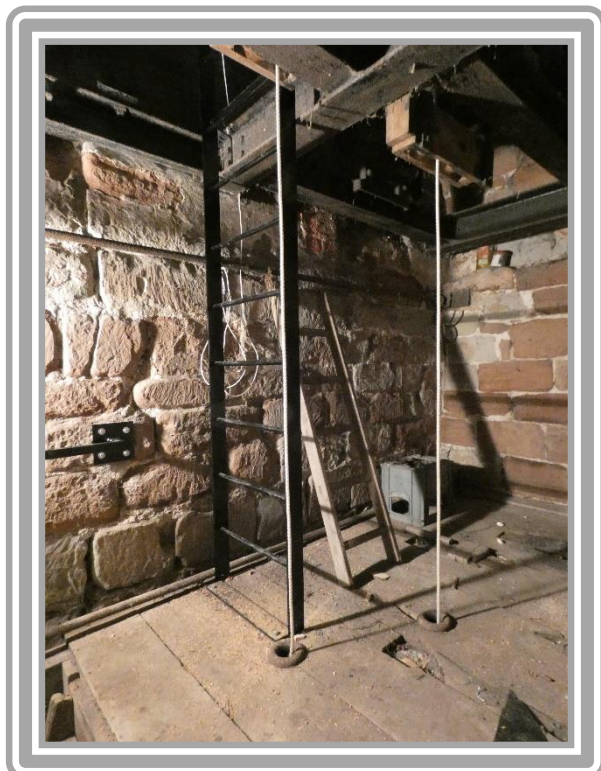
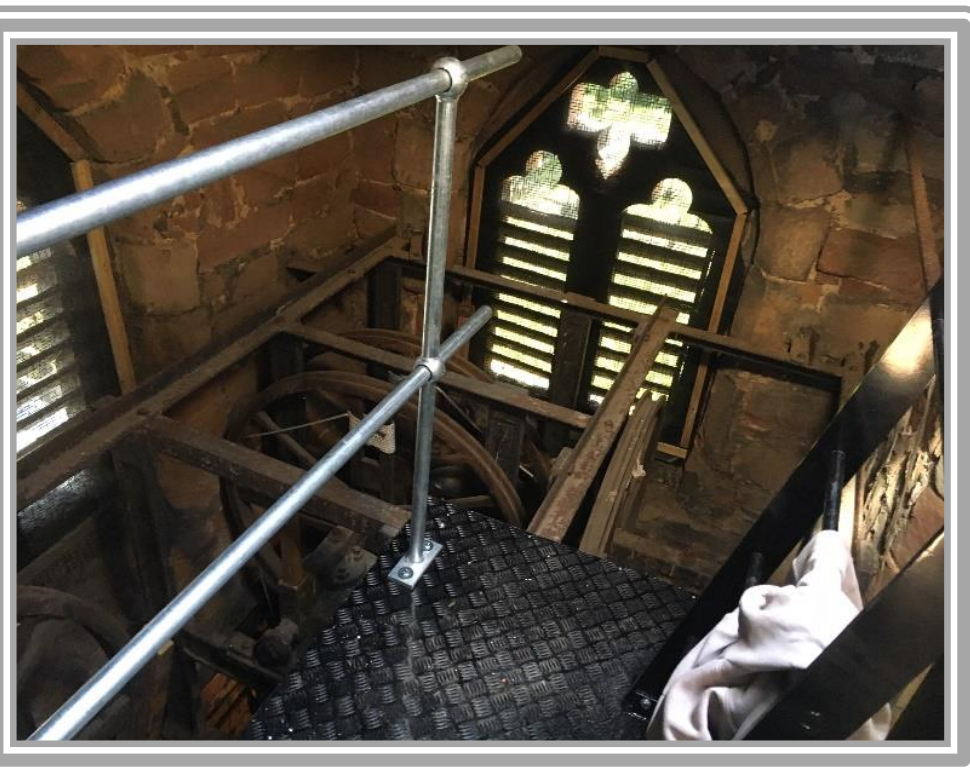
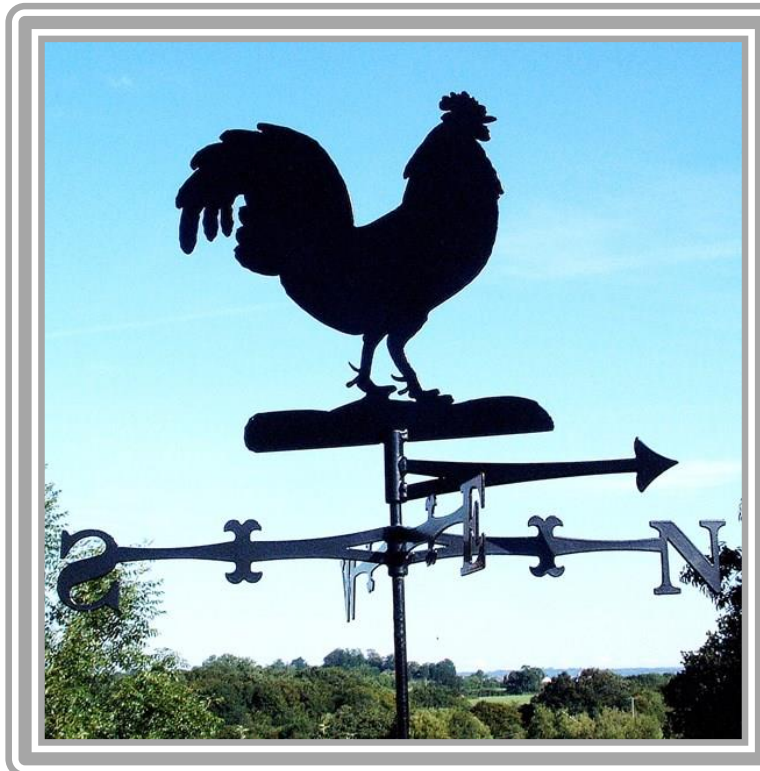
Unfortunately, the badly corroded weathervane could not be mended and re-erected. We are, however, hoping to be able to replace this with a rooster weathervane in the near future when we have sufficient funding.

Inside the tower, new access ladders leading from the belfry floor to the roof were installed. Damaged slats on the tower windows were replaced and new wire meshes attached. The small, square, roof hatch with a very heavy lead top was replaced with a larger hatch with a much lighter terne-coated stainless steel top which is far easier to lift open.

The old door to the ringing room on the outside of the north wall of the tower was replaced with a brand new oak door inside the new extension, and a new stone step was inserted.

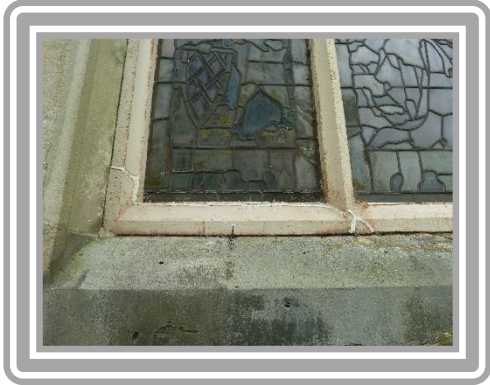
The large stained glass windows in the chancel are unusual because the jambs, mullions and tracery housing the leaded stained glass panels are made of hollow cast iron and the frames are built into the surrounding brickwork. As cutting out the frames would have been too destructive to the stonework, the internal plaster surrounds were cut back to allow the rusted edges of the frames to be treated and the cracks to be welded in-situ.

The stained glass panels in the east and south chancel windows were removed and taken off site to the Ark Stained Glass and Leaded Lights Ltd workshops. Here the panels were dismantled, re-leaded, cleaned and re-painted. The window paint was 'conserved' rather than 'restored'. So, only significant details such as the faces of the figures were added. One of the lovely results of this work was that in the large chancel window above the altar, Jesus has had his eyes restored!

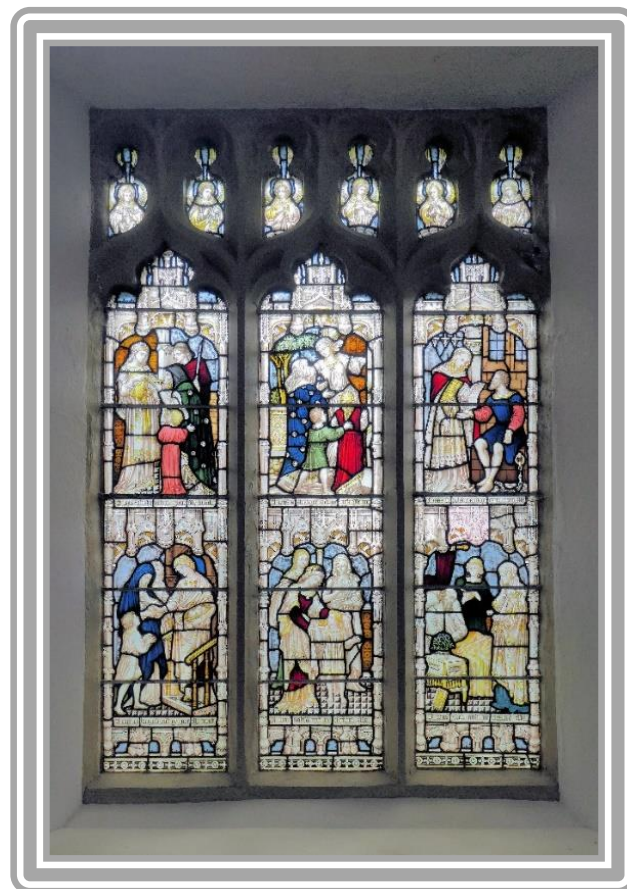
The cracked render on the nave and south porch walls was removed, new lime wash render was applied and the walls painted. New guttering and downpipes were attached to the porch to reduce future damage to the new render.

Unlike the chancel stained glass windows, the windows in the south aisle (*Sheep & Goats Window*) and nave (*Three Saints Window*) have stone surrounds, mullions and tracery. The outside sections of 3 of the 4 mullions were replaced. Damaged areas of the tracery in the south aisle window were repaired by inserting intricately carved stone sections matching the original stonework.
